**Asset ID: 6486**      **Glamis Walk, Hartlepool**

## Cover Sheet

# Fire Risk Assessment Survey Results

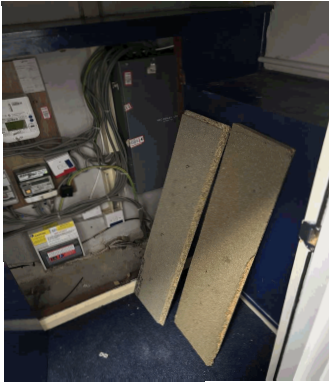
| Observation | Priority | Referred To | Required By: | Task ID |
|---|---|---|---|---|
| Chipboard left in electrical in take cupboard in block 5 - 6 | Internal - Medium | Housing Partner | 14/11/2025 | 2034958 |

Electrical intake cupboard within block 5- 6 has chipboard stored inside. Email sent to SHP on 16/10/2025 requesting removal.

Chip board left in electrical cupboard in block 5 -6 and door closer required for electrical intake cupboard in block 1 - 2

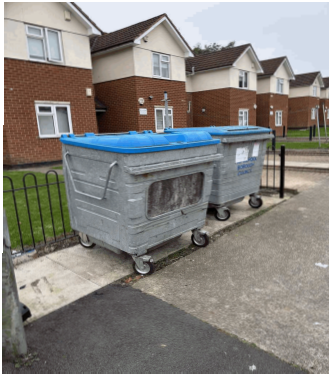
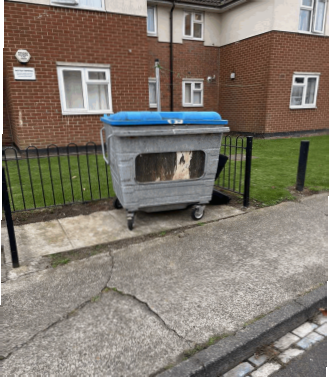
| Observation | Priority | Referred To | Required By: | Task ID |
|---|---|---|---|---|
| Designated refuse store | No Action | | | |

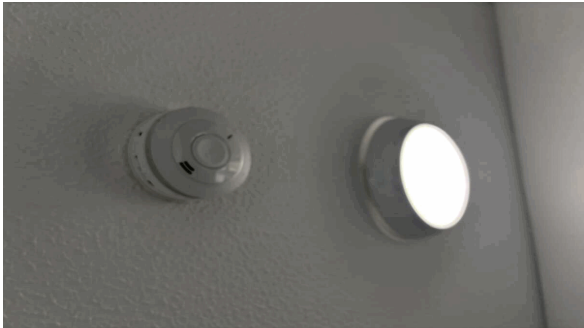
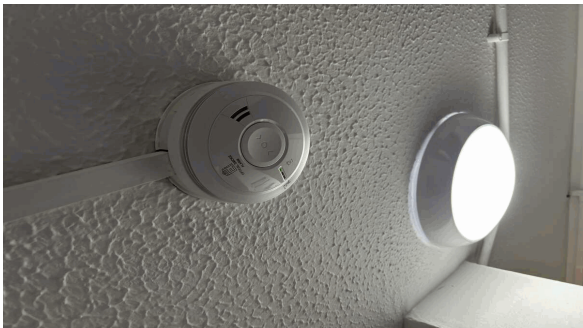
All lighting appears to be in good condition and secured

| Observation | Priority | Referred To | Required By: | Task ID |
|---|---|---|---|---|
| Lighting in good condition and secured | No Action | | | |

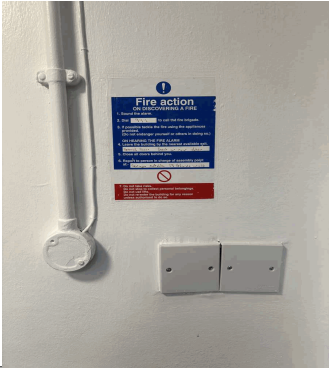
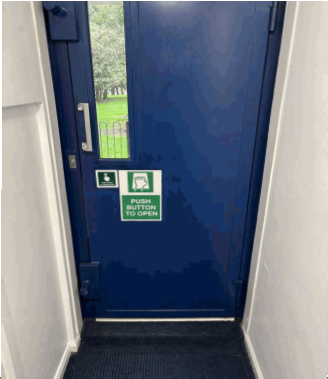
Positioned correctly throughout all blocks

| Observation | Priority | Referred To | Required By: | Task ID |
|---|---|---|---|---|
| Correctly positioned signage | No Action | | | |

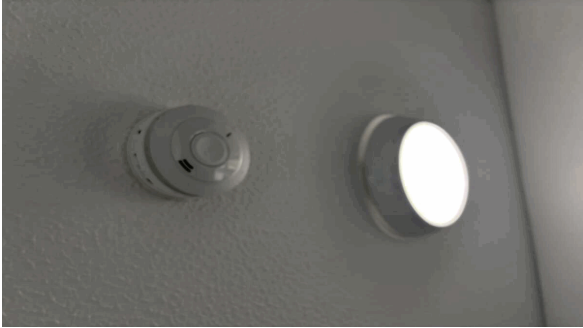
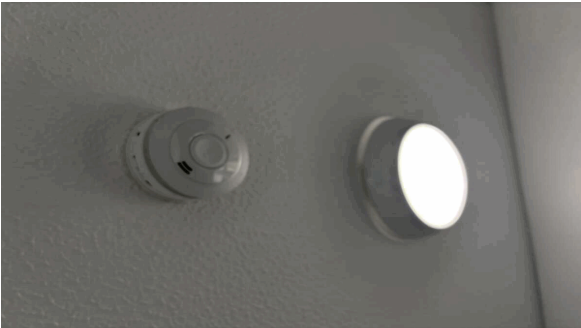
| Comment | All detectors in each block are to be of good condition and secured |

| Observation | Priority | Referred To | Required By: | Task ID |
|---|---|---|---|---|
| Detectors in good condition and secured | No Action | | | |
