This report shows all the responses to the Fire Risk Assessment survey, including raised tasks.

**Asset ID: 14**      **Nene Court Empingham Road, Stamford**

## Cover Sheet

| Type of Fire Risk Assessment | Type 1 (Common Parts Only - Non Destructive) |

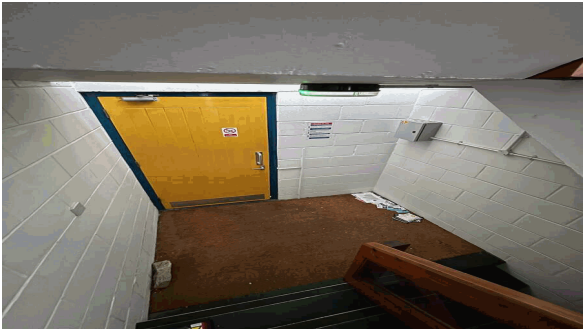
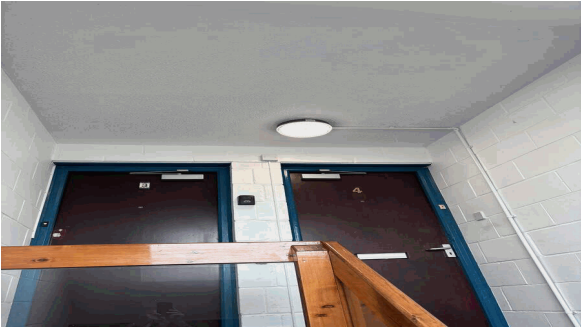
| Comment | All exit routes clear on inspection with 2 directions of travel. |

| Observation | Priority | Referred To | Required By: | Task ID |
|---|---|---|---|---|
| Clear in both Blocks good housekeeping. | No Action | | | |
