## **ACCENT HOUSING - FIRE RISK ASSESSMENT**

| <b>Scheme Name :</b> | <b>Stowehill road</b> |
| <b>Scheme Address :</b> | <b>32-42 Stowehill Rd<br/>Peterborough<br/>PE4 7PY</b> |
| <b>Date of Assessment:</b> | <b>11/02/2026</b> |

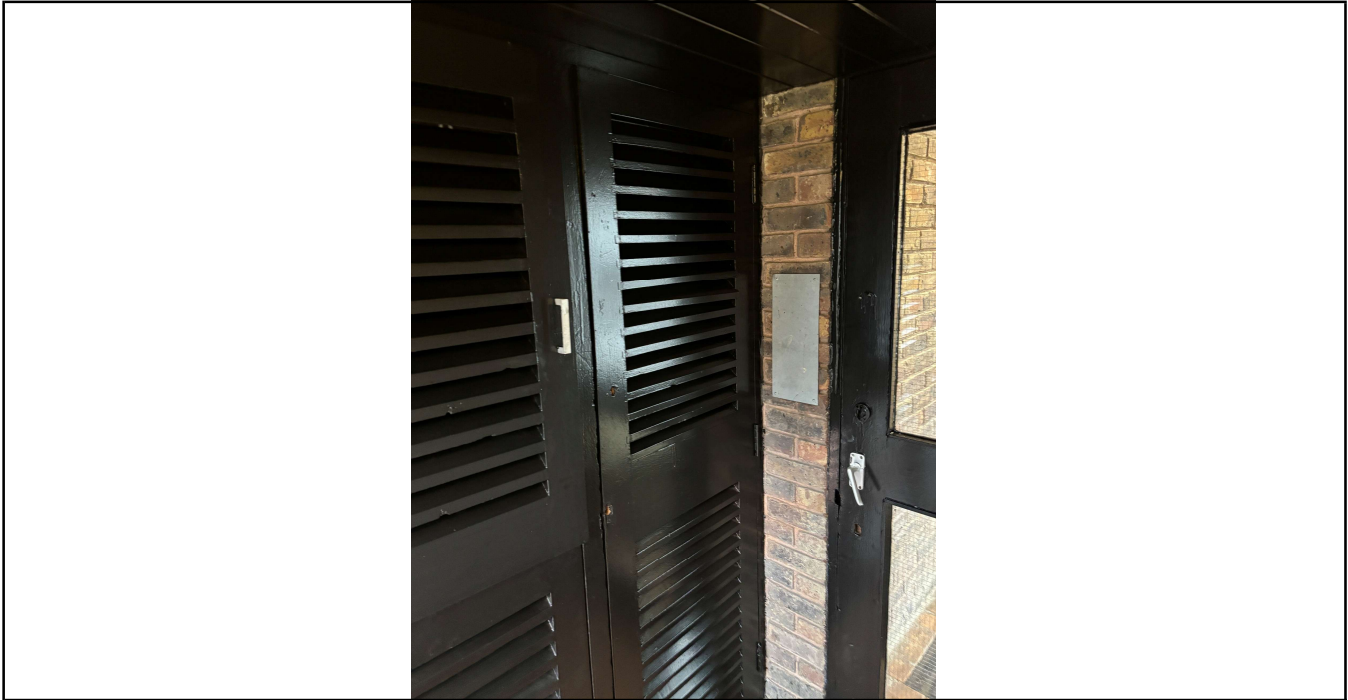
| Photo No. 1 | Fob Entry System |

| Significant Findings - Fire | | | | | | |
|---|---|---|---|---|---|---|
| 3.1 | Adequate security against arson? | Yes | A Fob system Exits entry door locked on the day of inspection. | . | | |

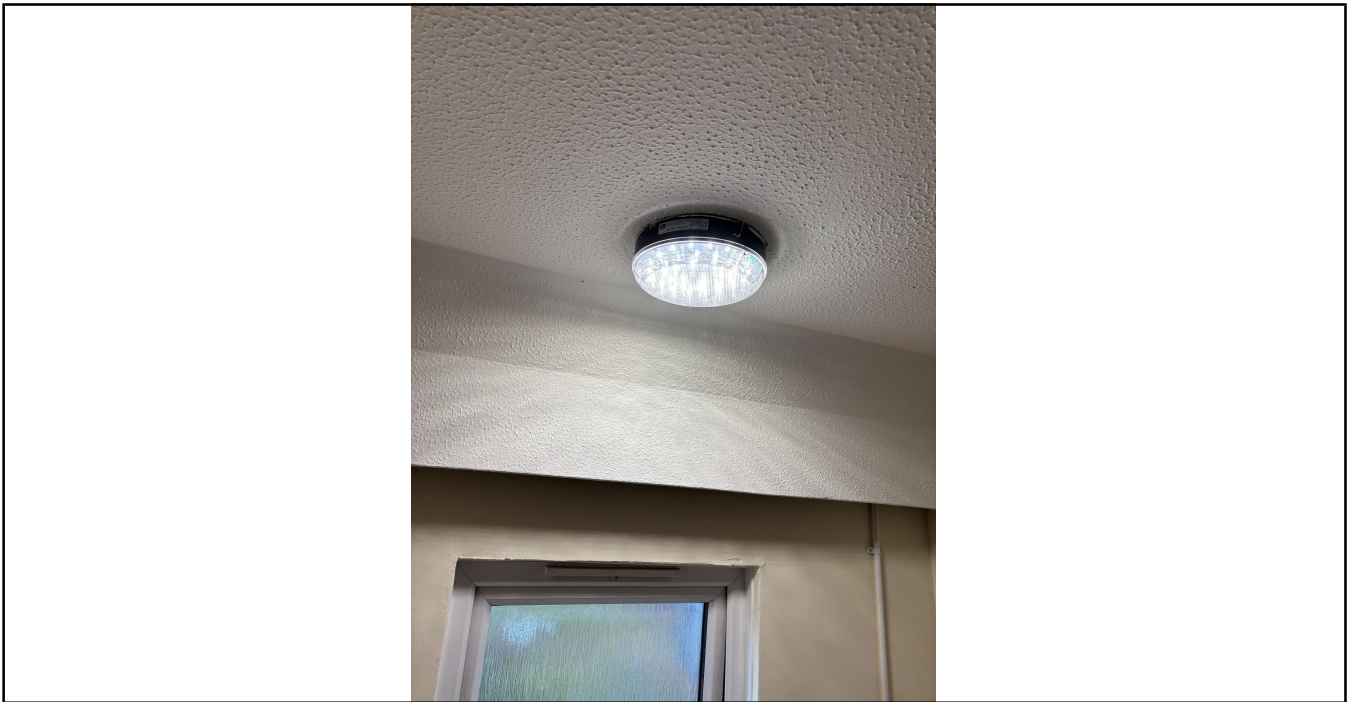
| Photo No. 4 | Maintained EML |

| 15.1 | Is the emergency lighting correctly specified and installed as per BS 5266-1:2016 | Yes | At time of inspection all seen to be working. | . | |
| 15.2 | Are all emergency lighting units in good condition and securely fixed to walls/ceilings | Yes | All in good condition at the time of inspection. | . | |

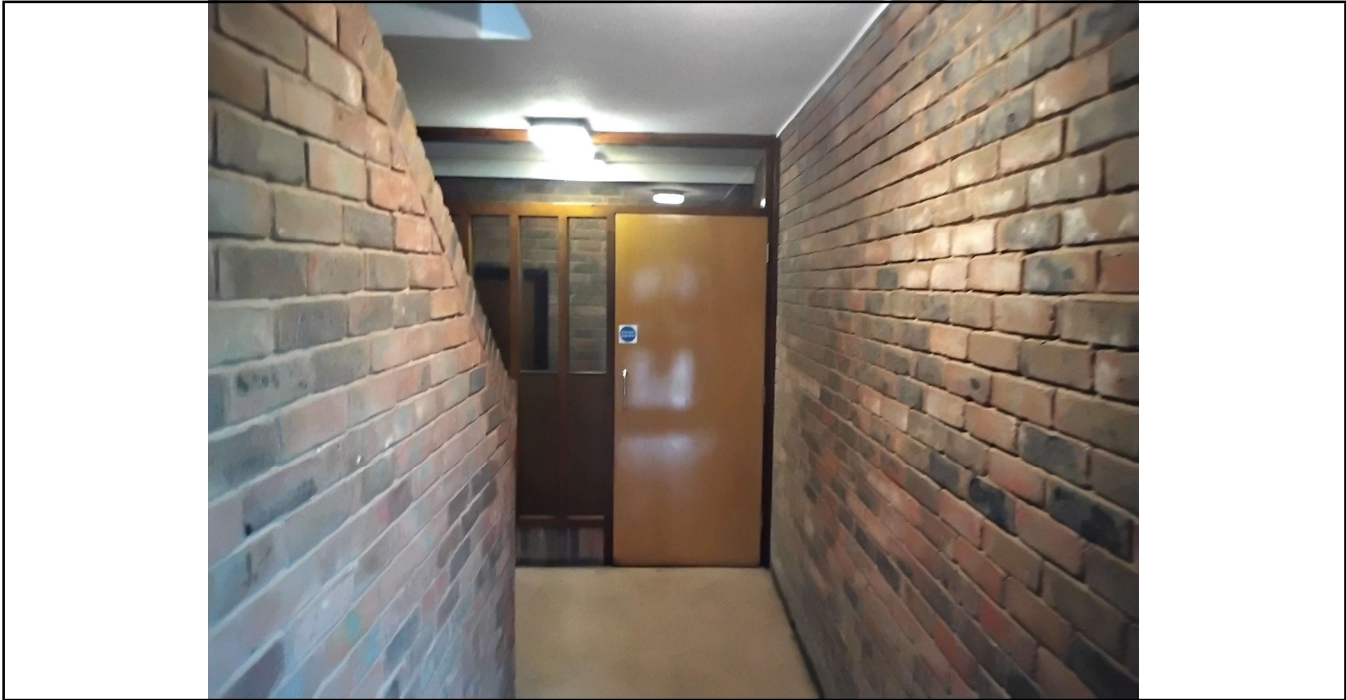
| Photo No. 5 | Communal first floor Smoke lobby. |

| 11.6 | Fire stopping above cross-corridor fire doors within suspended ceiling void of a satisfactory standard | N/A | Smoke lobby partition Georgian wired and single communal fire Door at ground and first floor level.No suspended ceiling. | . | | |

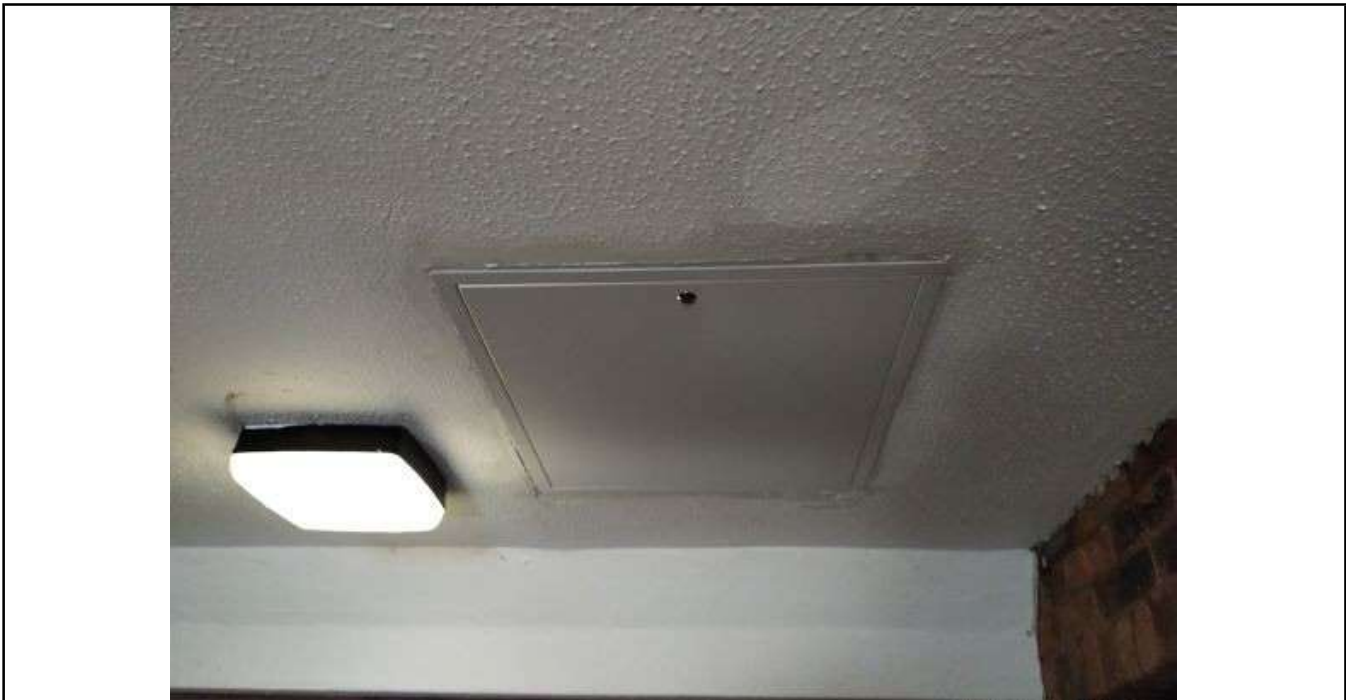
| 11.5 | Loft hatches fire resisting? | Yes | One hour Fire Rated Hatch within the communal area access made on day of inspection. | . | | |

| Photo No. 6 | One Hour Fire Resisting loft hatch replaced after 2023 FRA. |
