## **ACCENT HOUSING - FIRE RISK ASSESSMENT**

| <b>Scheme Name :</b> | <b>Meade Court.</b> |
| <b>Scheme Address :</b> | <b>12-31 Meade Court<br/>Bagshot, Surrey<br/>GU19 5NH</b> |
| <b>Date of Assessment:</b> | <b>18/02/2026</b> |

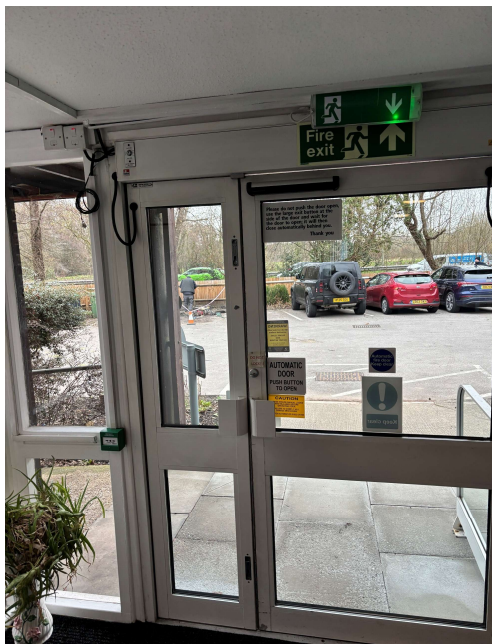
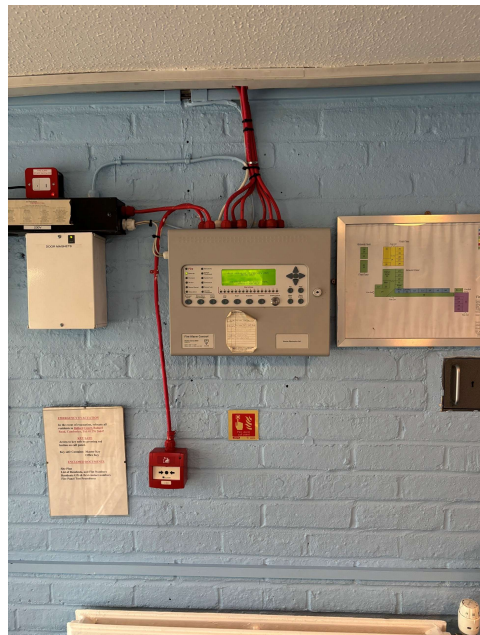
Photo No. 1

Electronic door entry system in place and Alarm panel. No faults showing.

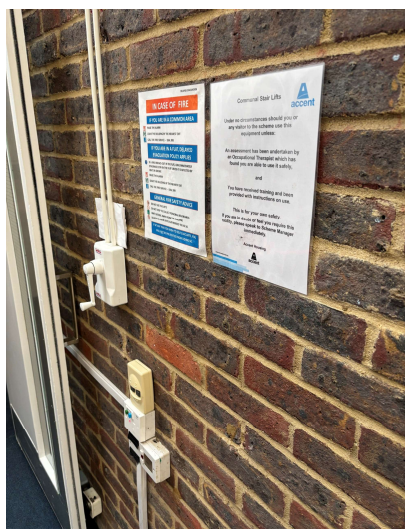
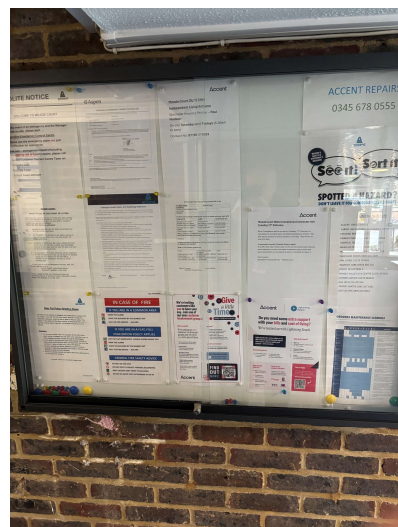
Photo No. 2

Evacuation policy posted throughout the scheme.

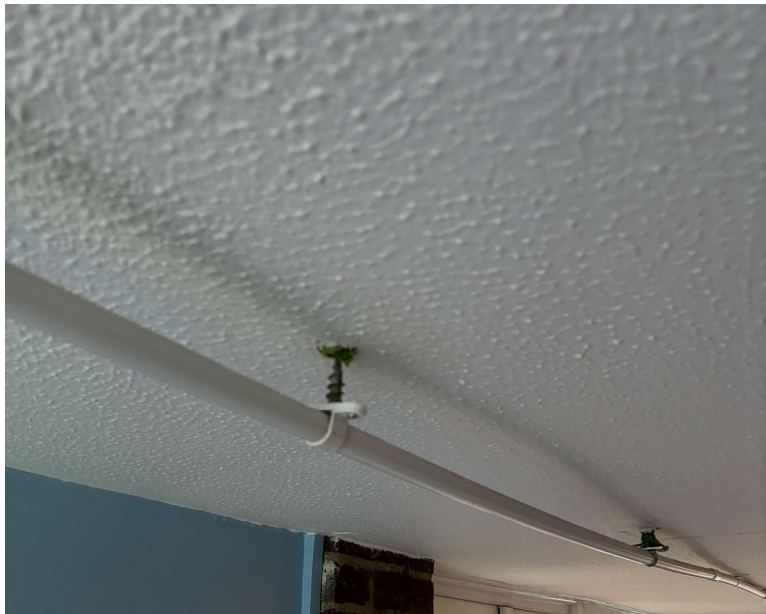
| Photo No. 3 | Metal conduit clips missing or dropped these need to be replaced. |

| Significant Findings - Fire | | | | | | |
|---|---|---|---|---|---|---|
| 1.5 | Absence of trailing leads and adapters | No | Although no trailing leads or adapters were present, the ceiling-mounted conduit is sagging due to failed fixings. These fixings must be replaced with metal clips to comply with the requirements of the 18th Edition Wiring Regulations. All areas should be inspected for similar issues. | . | | |

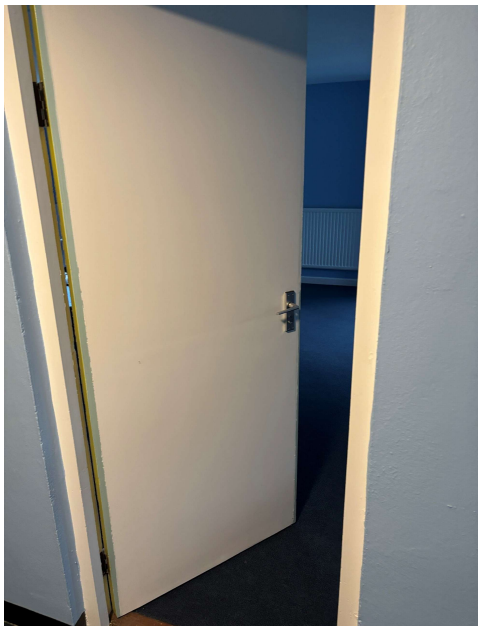
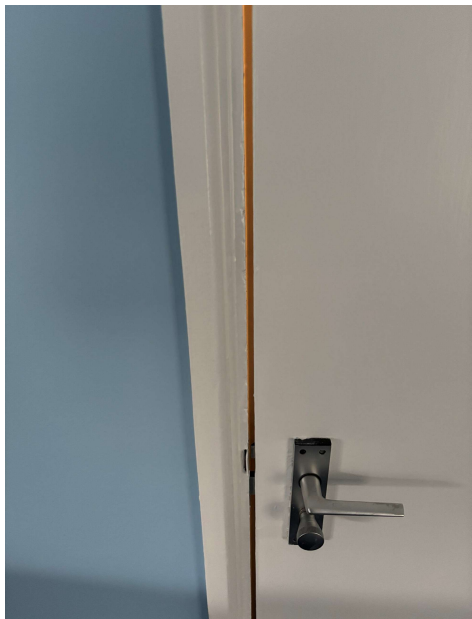
| Photo No. 4 | The alternative door from the communal area is not FR. |

| 10.1 | Is it considered that the building is provided with reasonable means of escape in case of fire? | No | The second door to the lounge area is not fire-rated and requires replacement or removal.<br>Proposed actions:<br>Replace the existing door set with an FD30s fire-rated door; or. Remove the door and install a false wall to provide 1-hour fire protection to the communal walkway behind.<br>Quotation requests have been raised under job numbers 1354478 and 1354480 | . | | |
| 10.2 | Escape routes unobstructed and safe to use? | No | There were no obstructions to the means of escape observed during the audit. However, works are required to the non-fire-rated (non-FR) door in the lounge, as it opens onto a designated means of escape (see Note 10.1). | . | | |

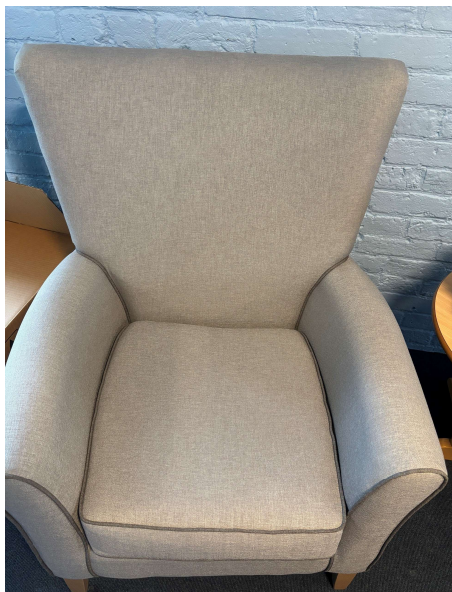
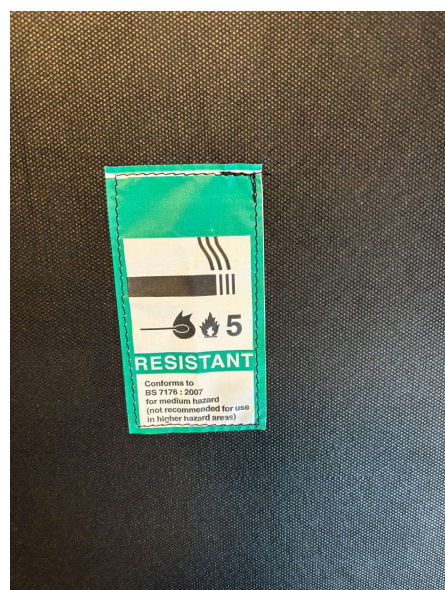
Photo No. 5

| 8.1 | Furniture/furnishings in good condition, fire retardant and complies with 1988 Regulations. | Yes | All upholstered furniture inspected was found to comply with the requirements of the Furniture and Furnishings (Fire) (Safety) Regulations 1988 | . | | |

All communal furniture complies to the latest standards.

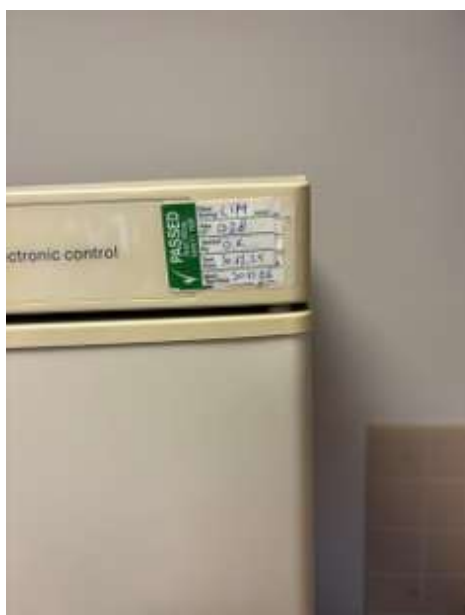
Photo No. 6

| Significant Findings - Fire | | | | | | |
|---|---|---|---|---|---|---|
| 1.4 | Electrical App/PA Testing - all portable appliances tested within past 12 months | Yes | Last PA Testing Date 30th December 2025. | . | | |

PA Testing. All items checked during the audit were in test date.

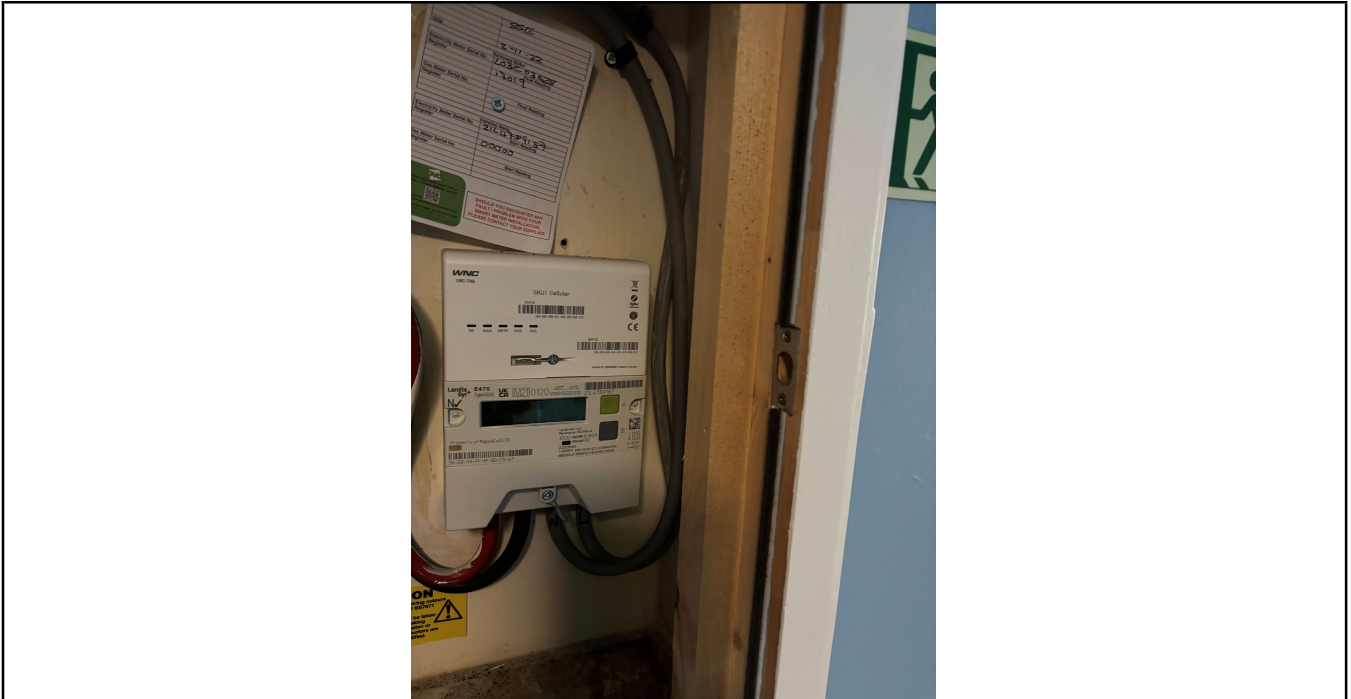
| Photo No. 7 | All electrical intake cupboard checked were clear of rubbish and Fire stopp |

| 7.2 | Are all electrical/intake/service cupboards secure and free from general waste, contractors waste and residents personal items. | Yes | | . | | |

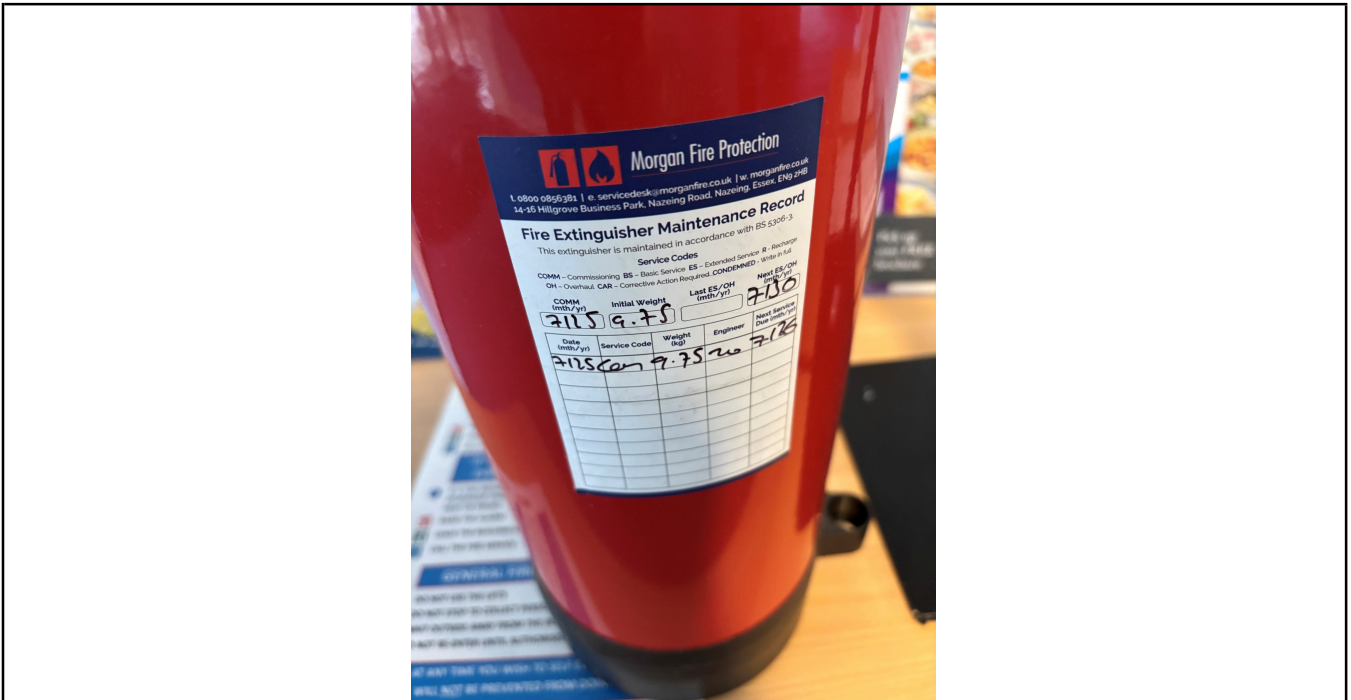
| Photo No. 8 | All extinguishers checked were in test date. |

| 18.6 | Records available of fire fighting equipment servicing within past 12 months | Yes | Last test date 7th July 2025 | . | | |

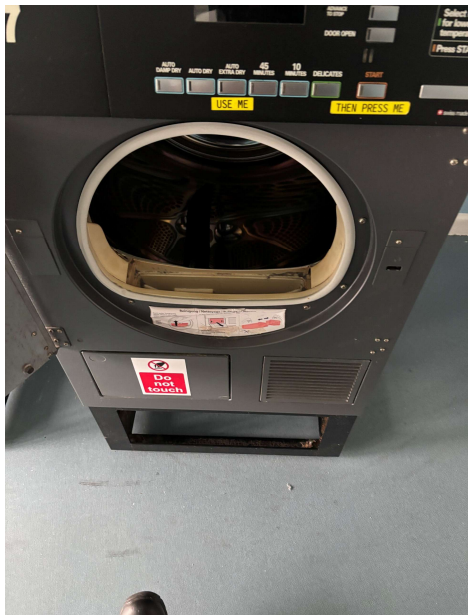
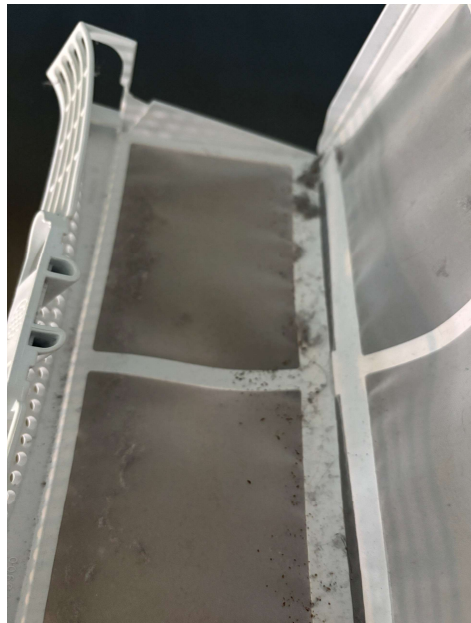
Photo No. 9

All driers were clean and in good working order.

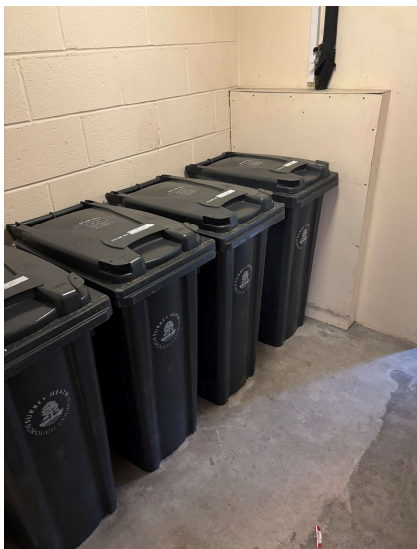
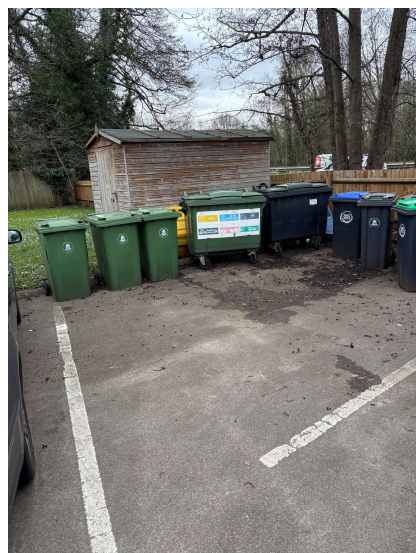
Photo No. 10

Satisfactory locations of the bin stores.

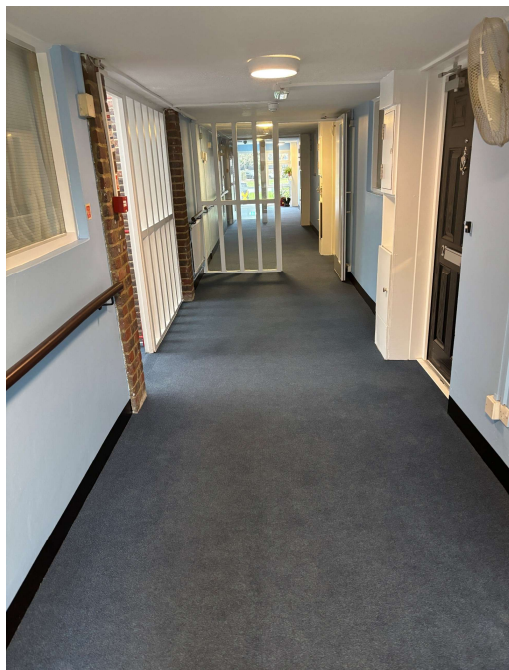
Photo No. 11

All areas were found to be clear during the audit.

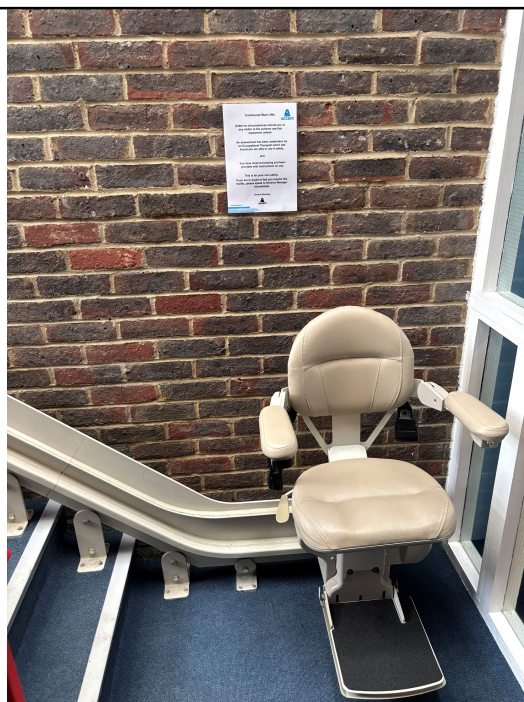
Photo No. 12

Stair lift and operating instructions to customers located in the main stairw
