## **ACCENT HOUSING - FIRE RISK ASSESSMENT**

| <b>Scheme Name :</b> | <b>26-36 Ringstead Road</b> |
| <b>Date of Assessment:</b> | <b>19/03/2026</b> |
| <b>FRA Frequency:</b> | <b>3 Year Re-Assessment under the<br/>Regulatory Reform (Fire Safety) Order<br/>2005</b> |

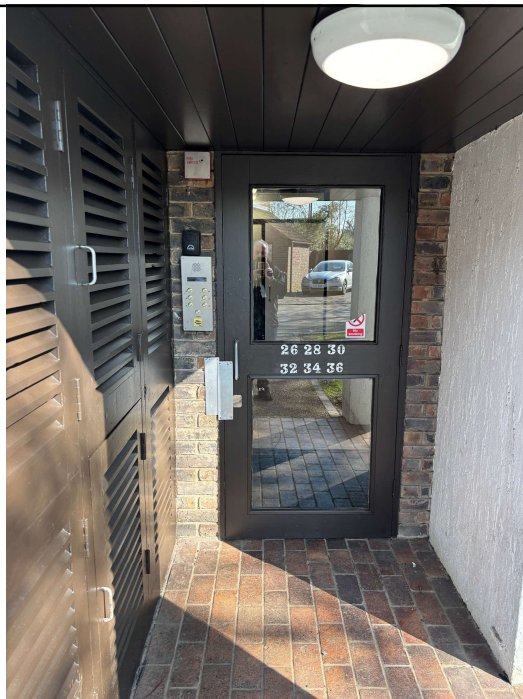
Photo No. 1

Main Access new security system Keypad and Trades.

| 3.1 | Adequate security against arson? | Yes | Keypad Access and Trades Button New System installed. | . | | |

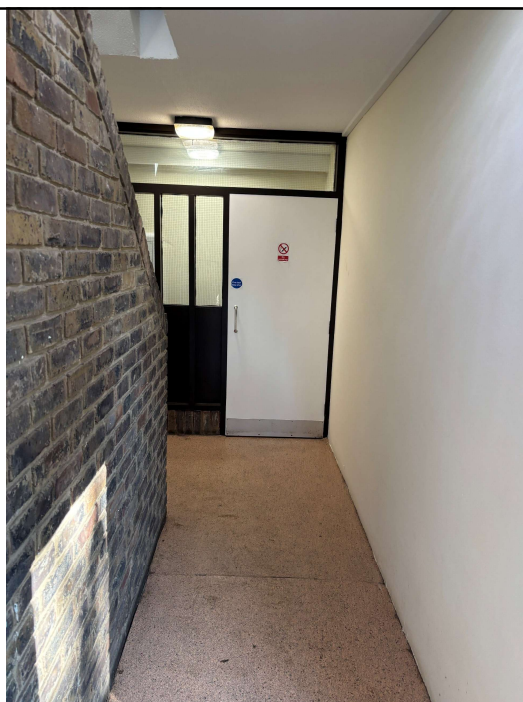
Photo No. 2

Ground Floor communal access and smoke lobby with communal Fire Door.

| 11.1 | Is it considered that the compartmentation is of a reasonable standard? | Yes | Smoke lobby areas on ground Floor and First Floor with Communal Fire Doors. | . | | |

| 12.1 | Communal fire doors to FD30s standard and in a serviceable condition, | Yes | There are communal smoke lobby partition with georgian wire and a Communal Fire Door on ground and First Floor. | . | | |

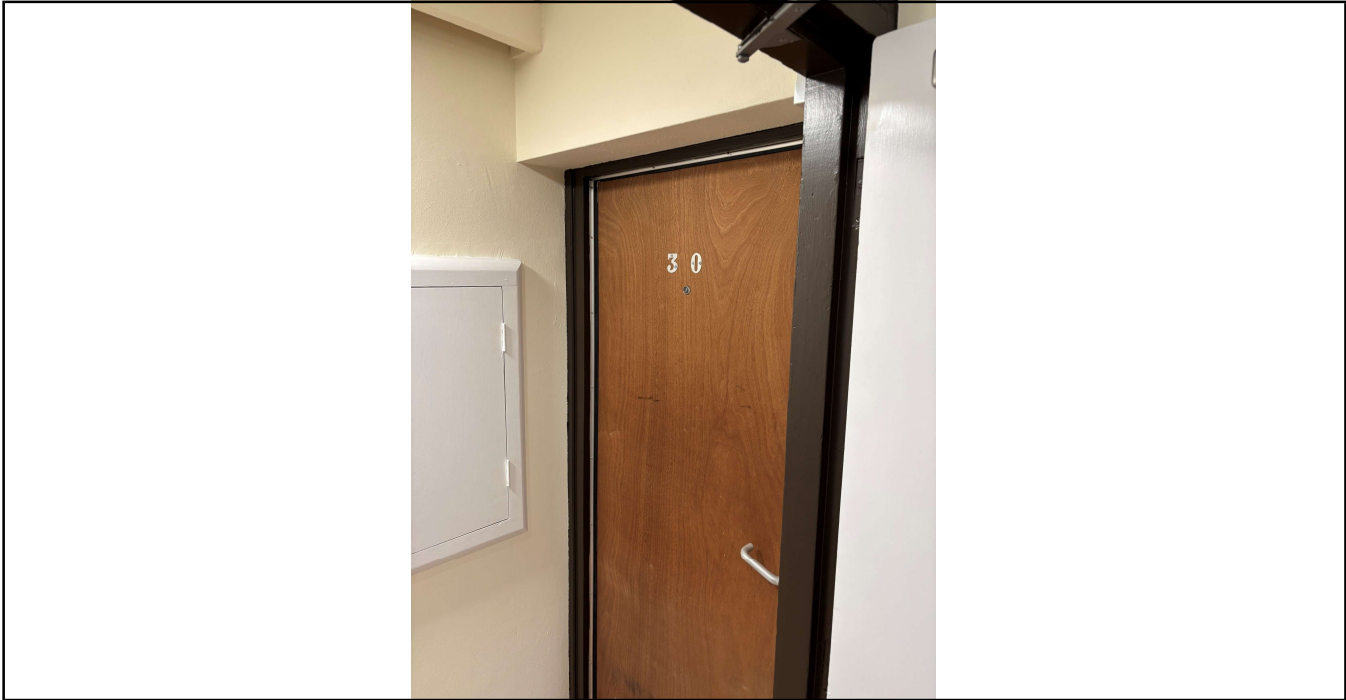
| Photo No. 3 | Standard Flat Door across the scheme. |

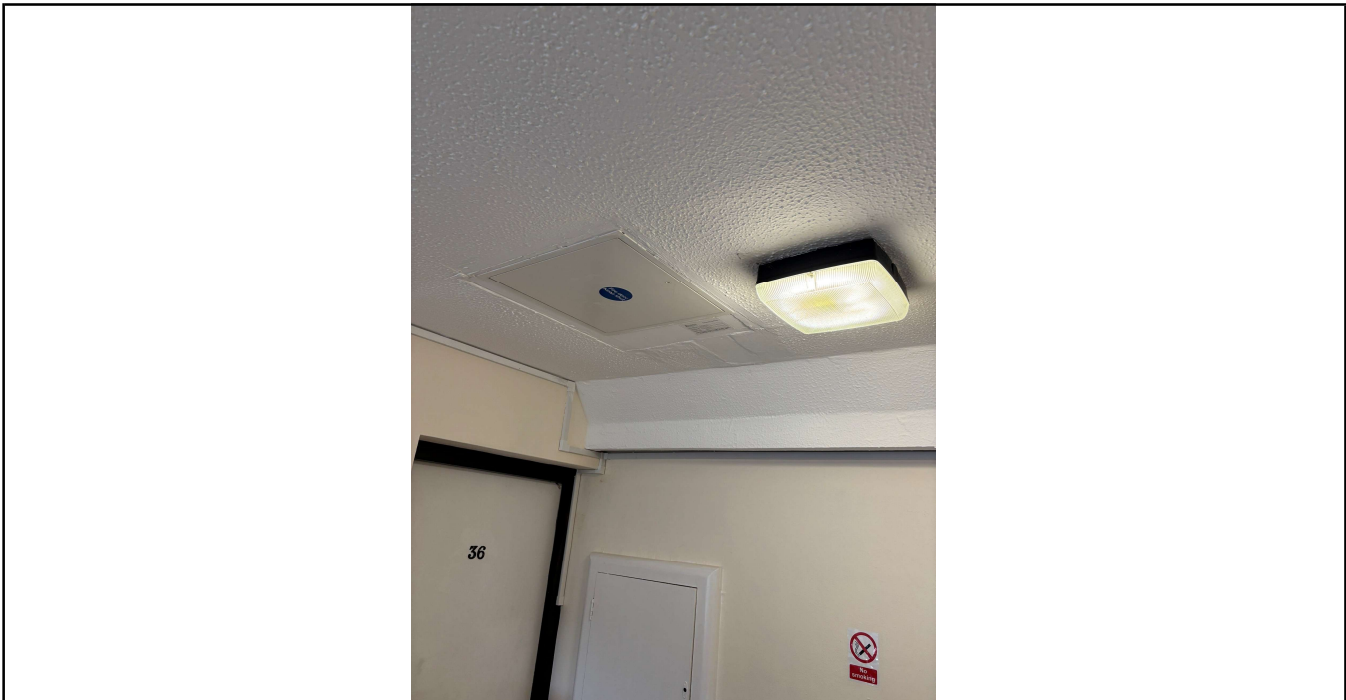
| Photo No. 4 | Top floor No Smoke lobby, Fire resisting loft Hatch<br>Maintained EML system. |

| 11.5 | Loft hatches fire resisting? | Yes | Loft hatch 1 Hr Fire resisting Hatch in top floor communal area. | . | | |

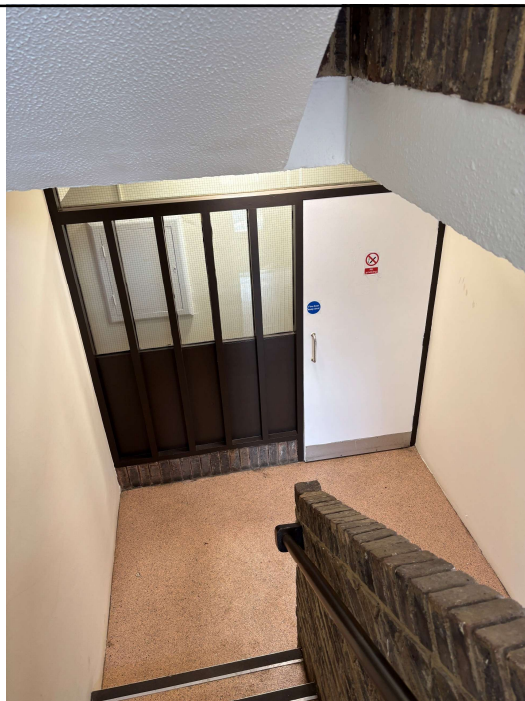
Photo No. 5

View Second floor (top) down to first Floor.

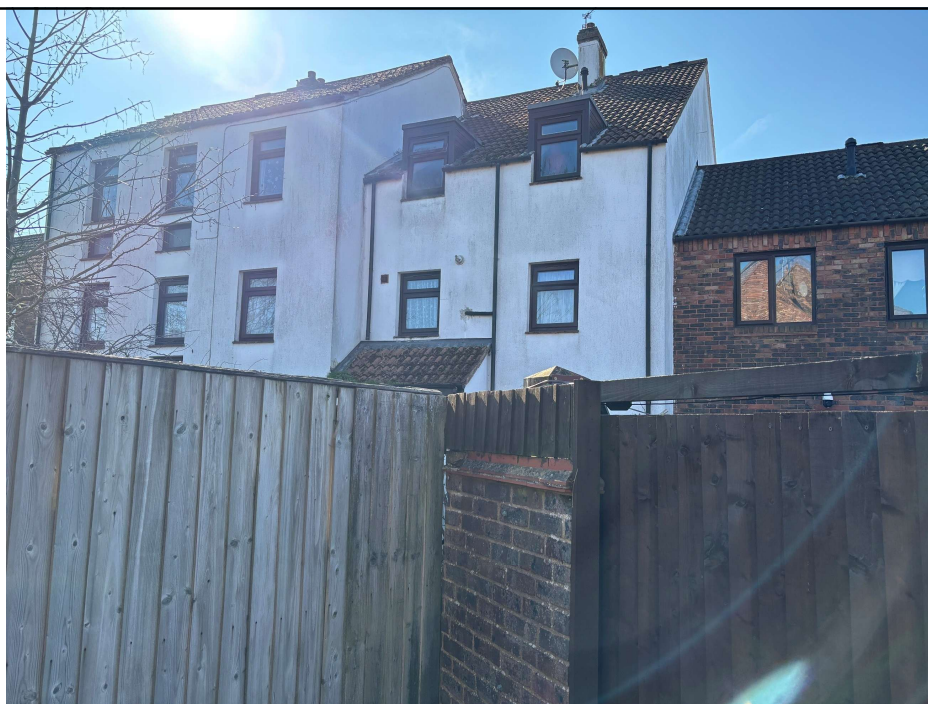
Photo No. 6

Rear of Block Cement Render Finish.
