## ACCENT HOUSING - FIRE RISK ASSESSMENT

| <b>Scheme Name :</b> | <b>Summerlin House 1-4</b> |
| <b>Date of Assessment:</b> | <b>19/02/2026</b> |

| Scheme Details | | Summerlin House 1-4 |
|---|---|---|
| Scope of Assessment | | Type 1 (Common Parts Only - Non Destructive) |

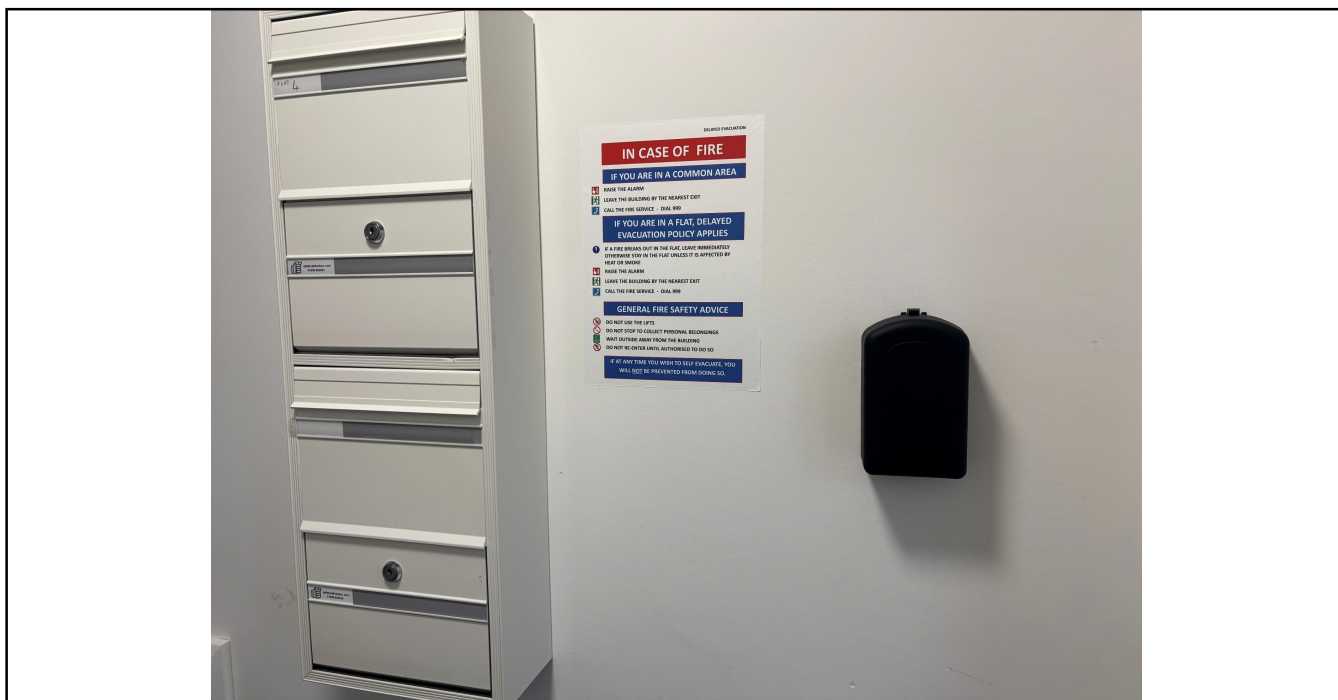
Photo No. 1

Main Entrance Fire Routine notice on entry to communal staircase  
Flats 3-4 on first floor, external flats 1-2 have own access Door.

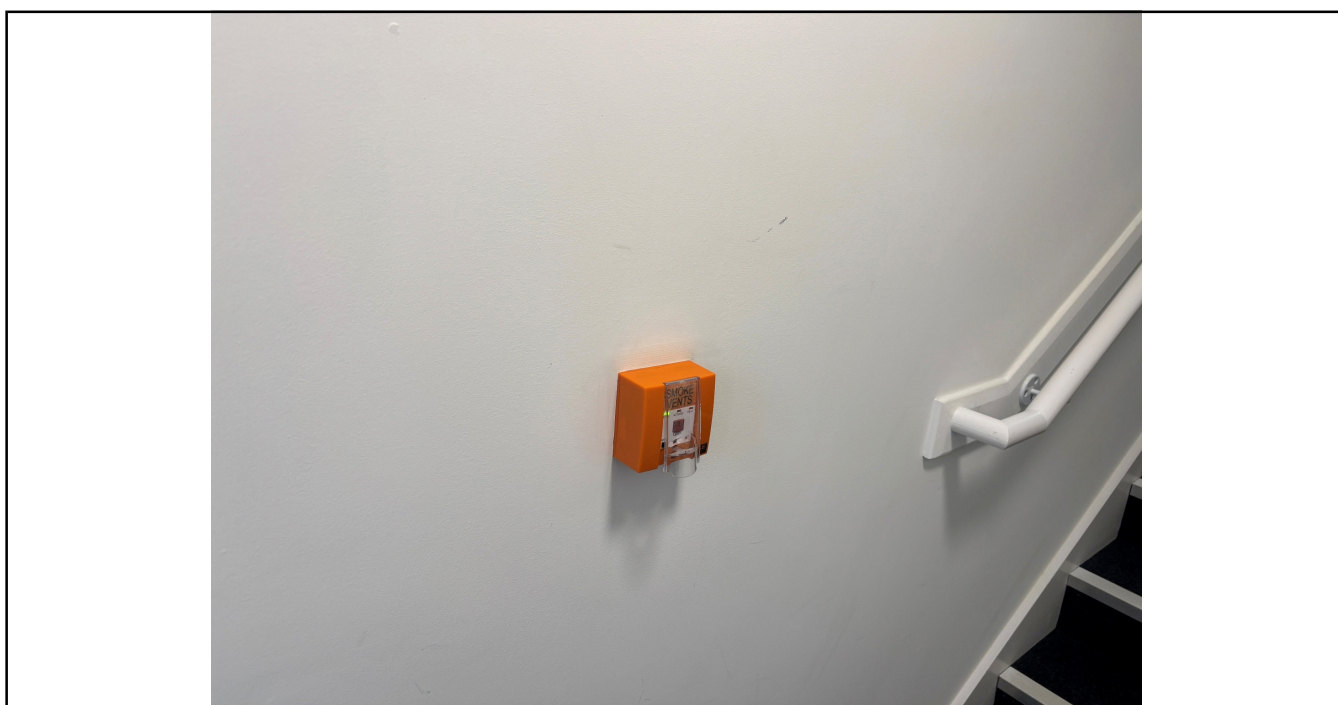
Photo No. 2

AOV Master control unit.

| 11.7 | Smoke Control Systems (AOV's)<br>Are records of annual testing available? | Yes | Automatic opening vent fitted at this scheme. Test certification on Active H and M files. | . | | |

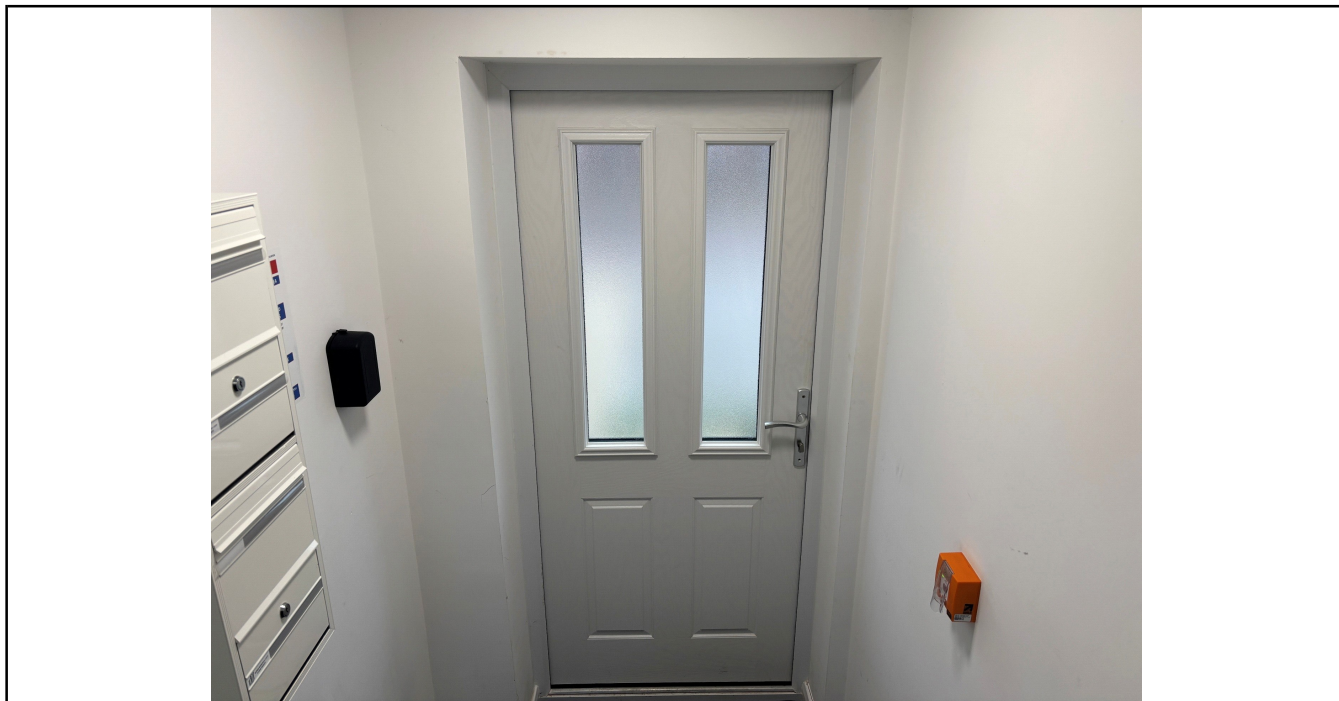
Photo No. 3

Main stairwell View access and Egress.

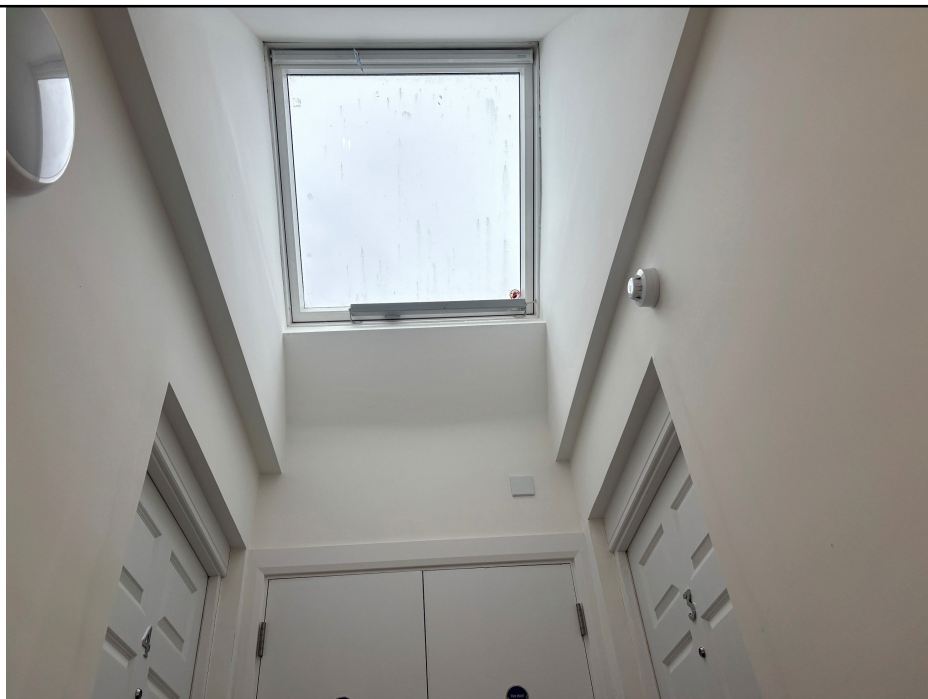
Photo No. 5

AOV head of stairwell no communal landing. Head of stairs Flats.
