## ACCENT HOUSING - FIRE RISK ASSESSMENT

| <b>Scheme Name :</b> | <b>73-78 The Martindales</b> |
| <b>Scheme Address :</b> | <b>The Martindales<br/>Clayton-Le-Woods<br/>PR6 7TJ</b> |
| <b>Date of Assessment:</b> | <b>9th Sept 26</b> |

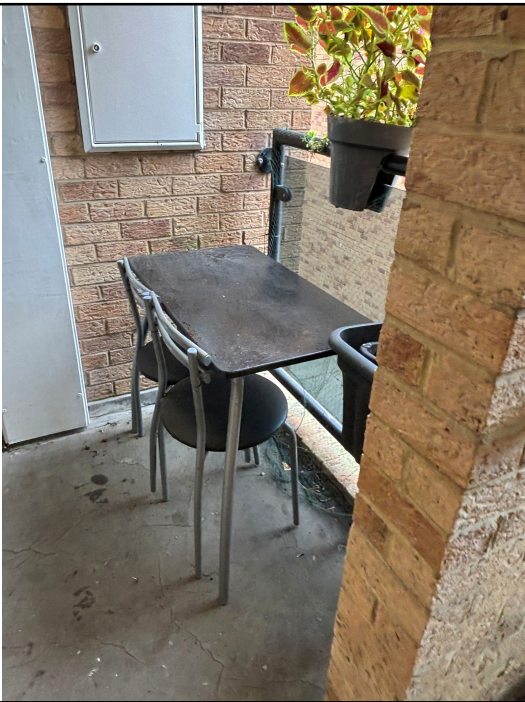
| Photo No. 1 | Personal items outside Flat 76 |

| 7.1 | Is the standard of housekeeping adequate? | No | Flammable personal items were found outside Flats 76 & 78. HP tasked to arrange removal. | Low | 30/9/26 |

| Action Plan - Fire | | | | | |
|---|---|---|---|---|---|
| Is the standard of housekeeping adequate? | Flammable personal items were found outside Flats 76 & 78. HP tasked to arrange removal. | Low | 30/09/26 | Housing Partner | 2181413 |
