ACCENT HOUSING - FIRE RISK ASSESSMENT

Scheme Name : St Pauls Road

Scheme Address : St Pauls Road
Bradford
BD8 7LU

Date of Assessment: 16/11/2023

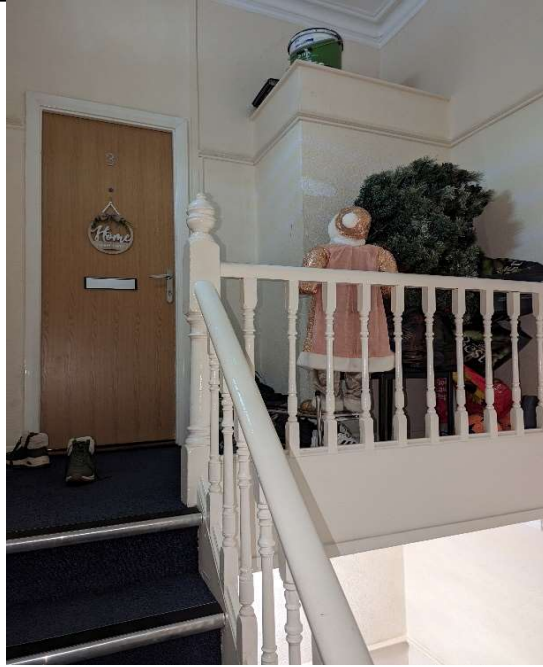
Photo No. 1

10.1	Is it considered that the building is provided with reasonable means of escape in case of fire?	Yes		.		
10.2	Escape routes unobstructed and maintained in a sterile condition?	No	House 40 Combustible Items outside flat 3 and in the halway on ground floor. See Pics 1 and 2	Med	31/1/24	Partnership Manager 1

40 St Paul's Road Flat 3

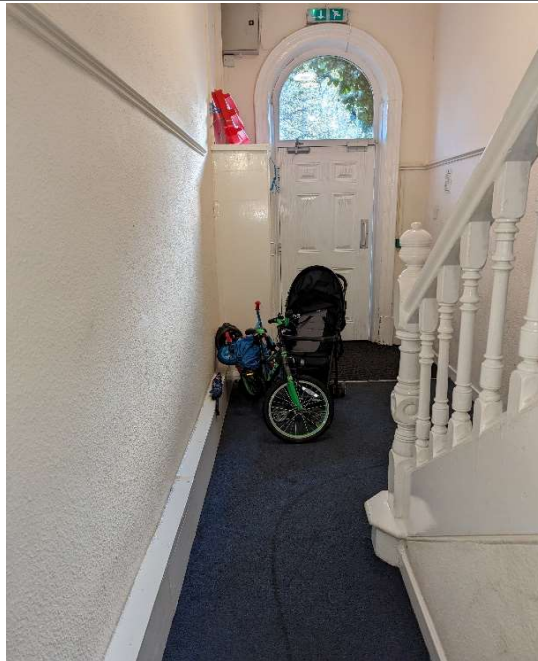
Photo No. 2

40 St Pauls Road Ground Floor
