## **ACCENT HOUSING - FIRE RISK ASSESSMENT**

| <b>Scheme Name :</b> | <b>Block 22 - 25 Claremont Court</b> |
| <b>Date of Assessment:</b> | <b>09/04/2026</b> |
| <b>Fire &amp; Safety Assessor</b> | <b>Kevin Jones GIFireE</b> |

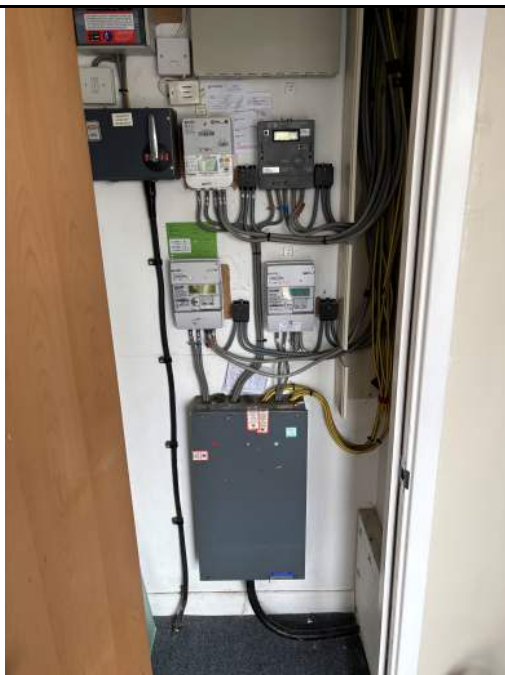
Photo No. 1

| 7.2 | Are all electrical/intake/service cupboards secure and free from general waste, contractors waste and residents personal items | Yes | Cupboards are locked at all times and are free from any items stored. | | |

Electrical intake cupboard

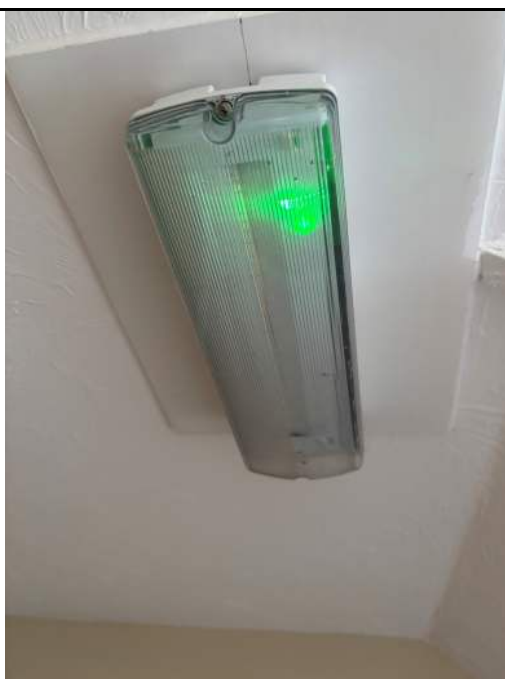
Photo No. 2

| 15.2 | Are all emergency lighting units in good condition and securely fixed to walls/ceilings | Yes | All in good condition and secure at the time of inspection. | . | | |

Emergency lights in good condition

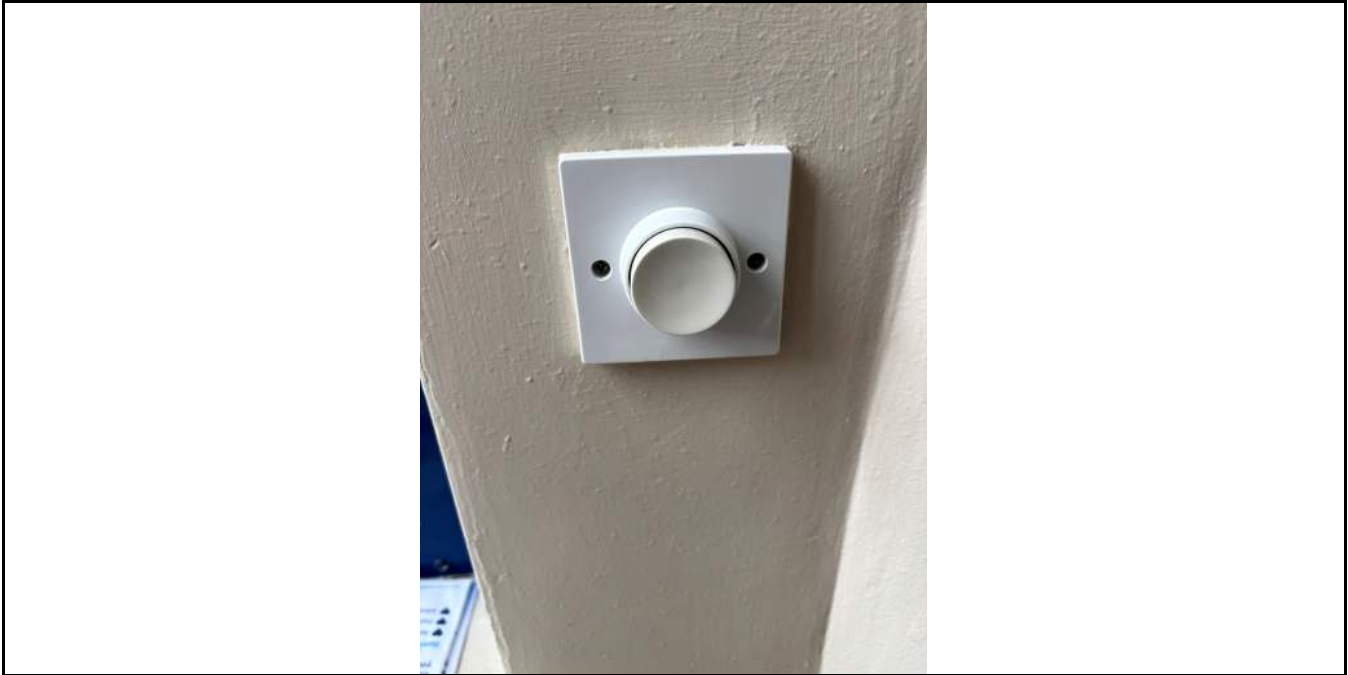
| Significant Findings - Fire | | | | | | |
|---|---|---|---|---|---|---|
| 1.1 | Electrical Installation within common areas (Fixed Wiring, sockets, switches, light fittings) in good condition and no obvious damage | Yes | All common area sockets and fittings in a satisfactory condition at the time of inspection | . | | |

| Photo No. 5 | Electrical fittings in good condition |
