## ACCENT HOUSING - FIRE RISK ASSESSMENT

| <b>Scheme Name :</b> | <b>Pilton Close</b> |
| <b>Scheme Address :</b> | <b>8-14 Pilton Close<br/>Peterborough<br/>PE4 7PU</b> |
| <b>Date of Assessment:</b> | <b>09/02/2026</b> |

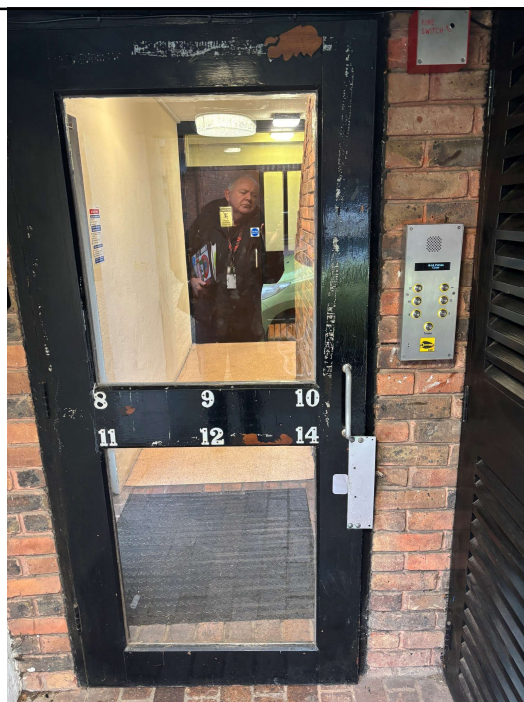
Photo No. 1

| Significant Findings - Fire | | | | | | |
|---|---|---|---|---|---|---|
| 3.1 | Adequate security against arson? | Yes | Fob Entry System to main entrance. | . | | |

Fob Entry System

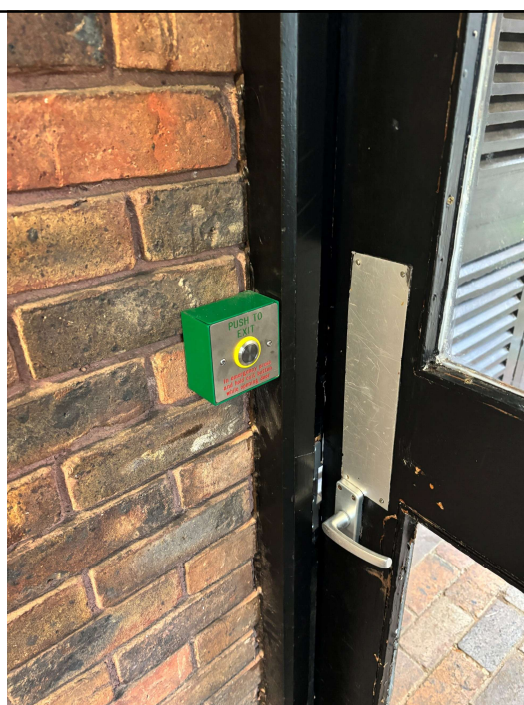
Photo No. 2

| 10.6 | Do failsafe's on locked exit doors function correctly? | Yes | On day inspection emergency release tested. | . | | |

Fire Exit Emergency Opening

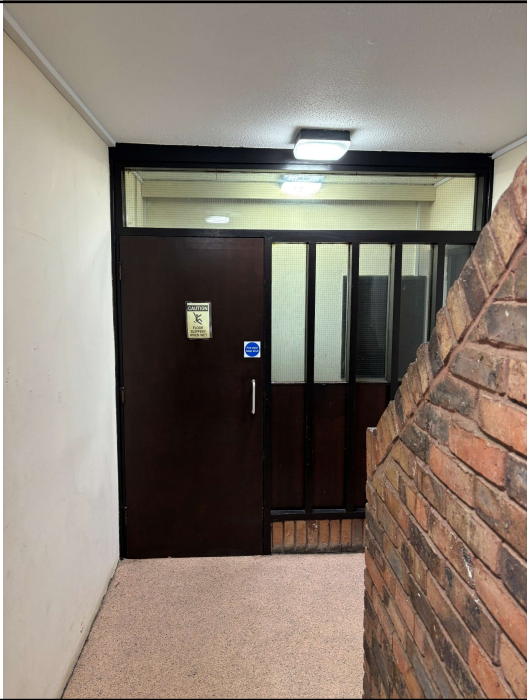
Photo No. 3

Groud Floor Smoke Lobby.

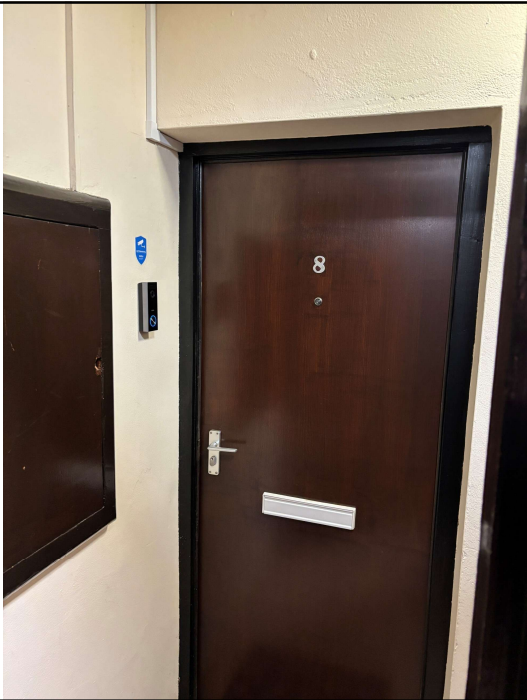
Photo No. 4

| 12.1 | Communal fire doors to FD30s standard and in a serviceable condition, | Yes | A communal doors in serviceable condition at the time of inspection. | . | | |

Standard Fire Door.

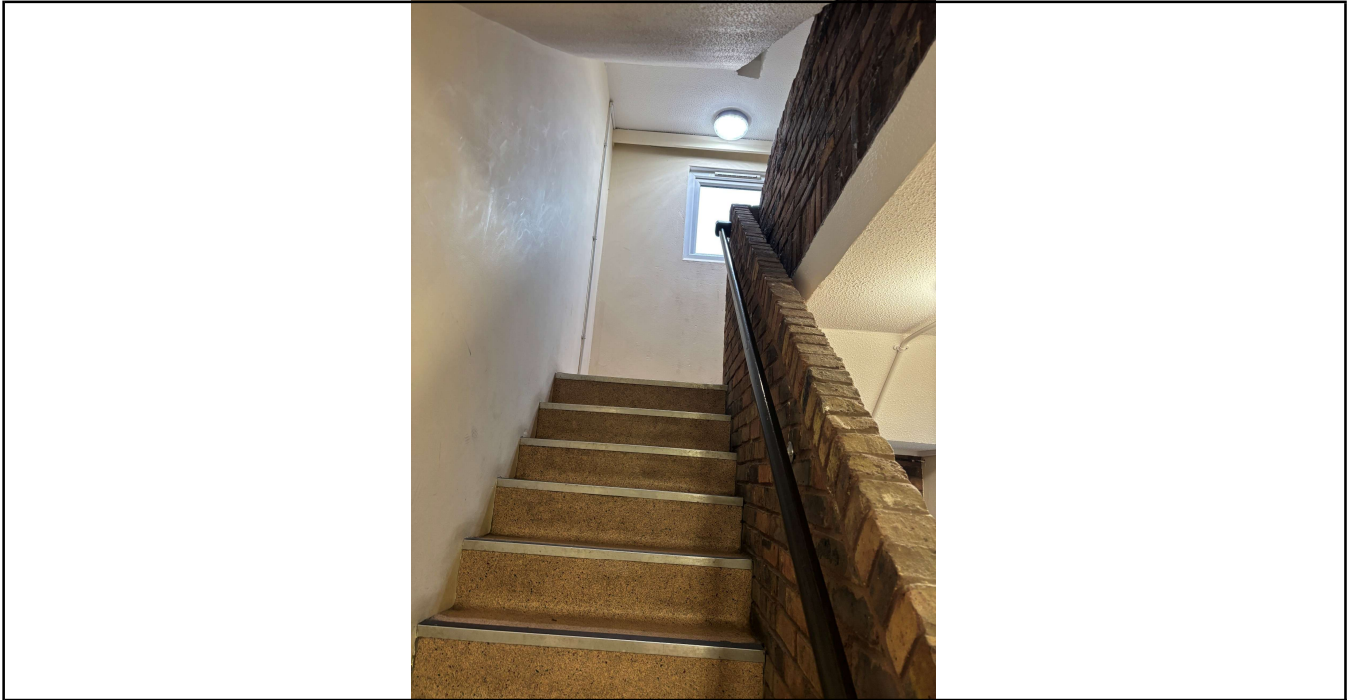
| Photo No. 5 | Ground To First Floor |

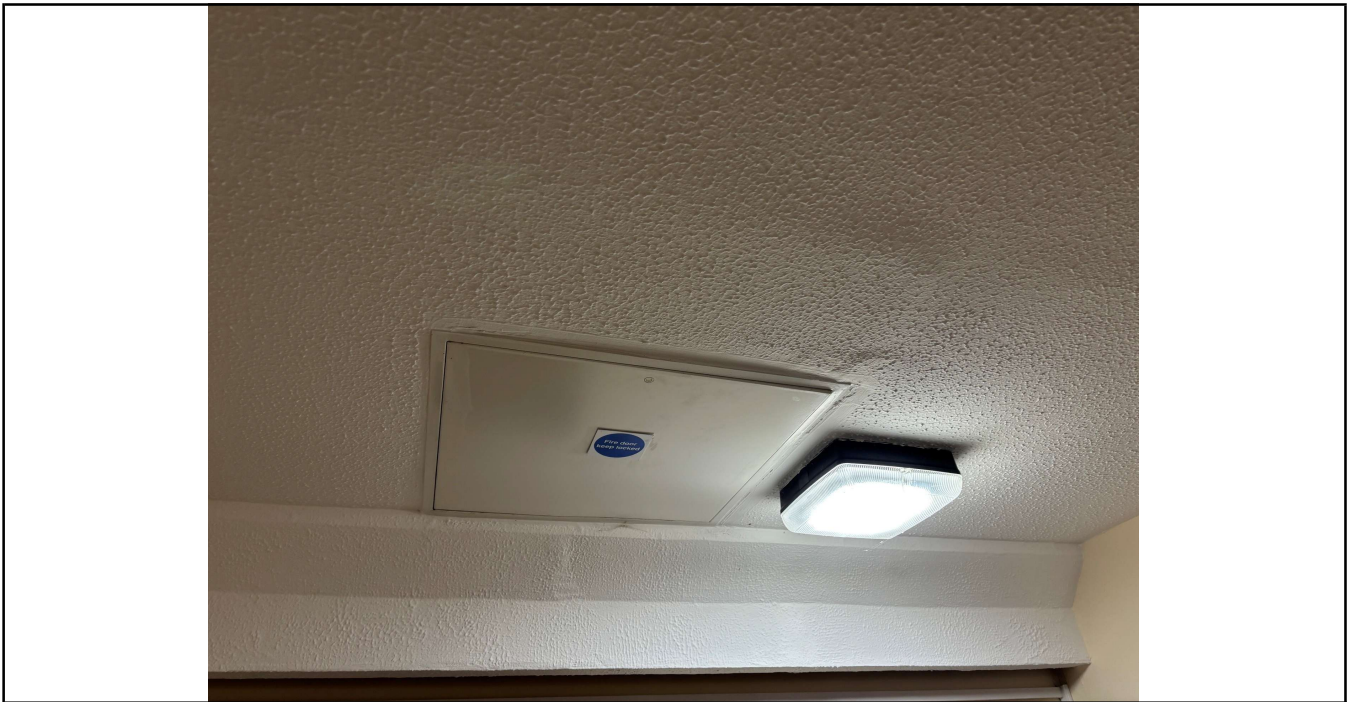
| 11.5 | Loft hatches fire resisting? | Yes | Fitted within the communal area. | . | | |

| Photo No. 6 | Fire Resisting Loft Hatch. |

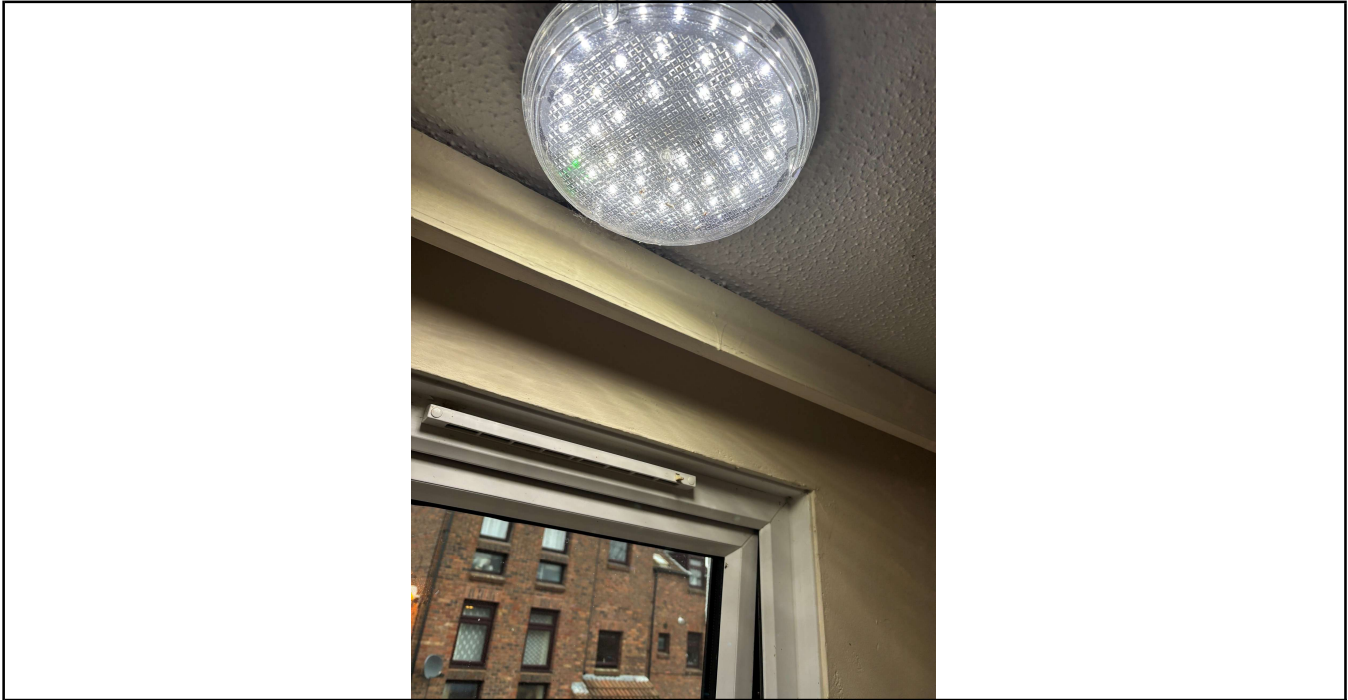
| 15.2 | Are all emergency lighting units in good condition and securely fixed to walls/ceilings | Yes | All in good condition at the time of inspection. | . | | |

| Photo No. 7 | Emergency Lighting. |
