## ACCENT HOUSING - FIRE RISK ASSESSMENT

| <b>Scheme Name :</b> | <b>Astura Court</b> |
| <b>Scheme Address :</b> | <b>Potternewton Mount<br/>Leeds<br/>LS7 2DL</b> |
| <b>Date of Assessment:</b> | <b>19/02/2026</b> |

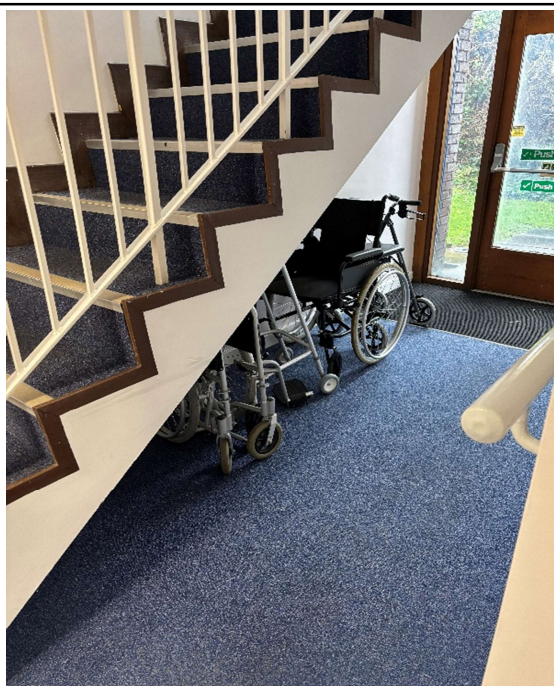
Photo No. 1

| 10.2 | Escape routes unobstructed and safe to use? | Other | Some plastic flowers were found in the escape route outside flats 24 and 27. There were wheel chairs found under one of the stairs. Scheme Manager informed at the time of inspection and email sent Items to be removed. | Low | 27/2/26 | Specialist Housing Partner |

Wheelchair and walking aids under the stairs.

| Action Plan - Fire | | | | | |
|---|---|---|---|---|---|
| Escape routes unobstructed and maintained in a sterile condition? | Some plastic flowers were found in the escape route outside flats 24 and 27. There were wheel chairs found under one of the stairs. Scheme Manager informed at the time of inspection and email sent Items to be removed. | Low | 27/02/26 | Specialist Housing Partner | |

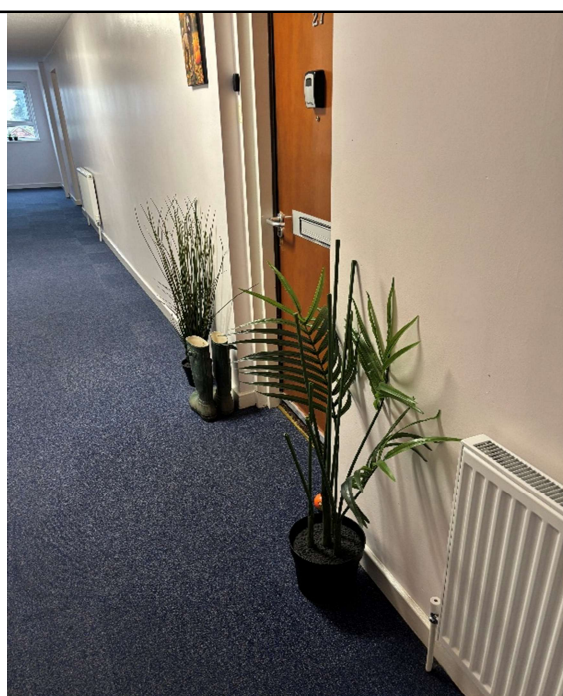
Photo No. 2

Picture on wall and plastic flowers on escape route.

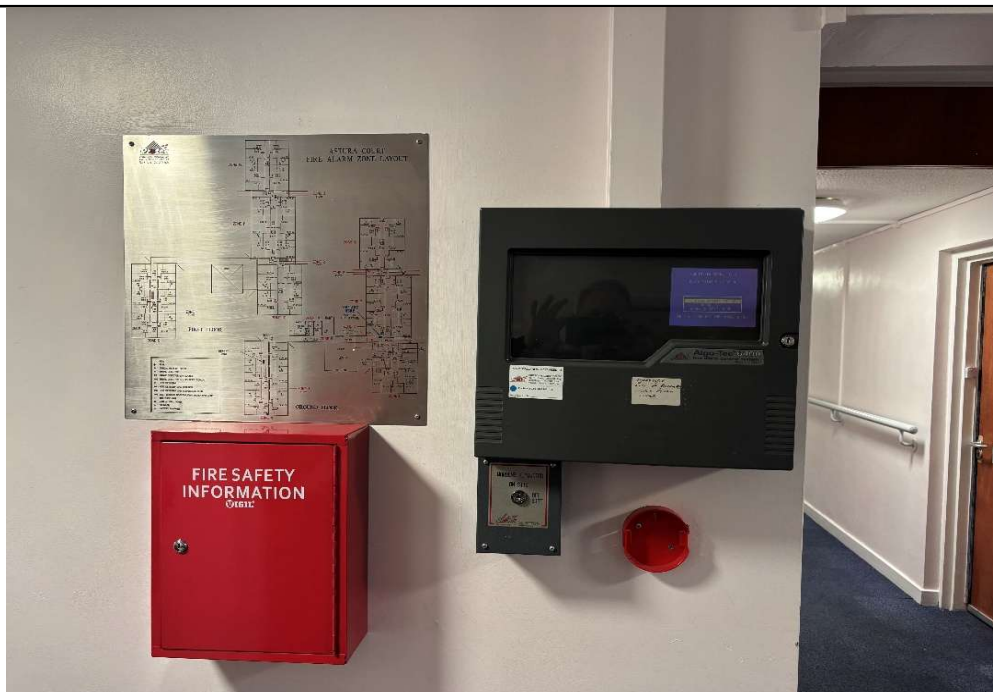
Photo No. 3

| 17.1 | Is the fire detection and warning system appropriate for the occupancy and fire risk? | Yes | There is a dual Fire alarm system within the scheme. The communal areas are protected with smoke and heat detection, this includes storage cupboards and electrical rooms. The flats have detection which is monitored by a warden call system. | . | | |
| 17.5 | Is the fire alarm panel remotely monitored, and if so are there records of regular testing? | Yes | Testing is carried out weekly by the Scheme Manager (SHP) and the 6 Monthly test is carried out by our contractors Tunstall Last test date weekly : - 19/02/2026 Last test date 6 Monthly : - 16/12/2025 | . | | |

Fire Panel and Zone plan.

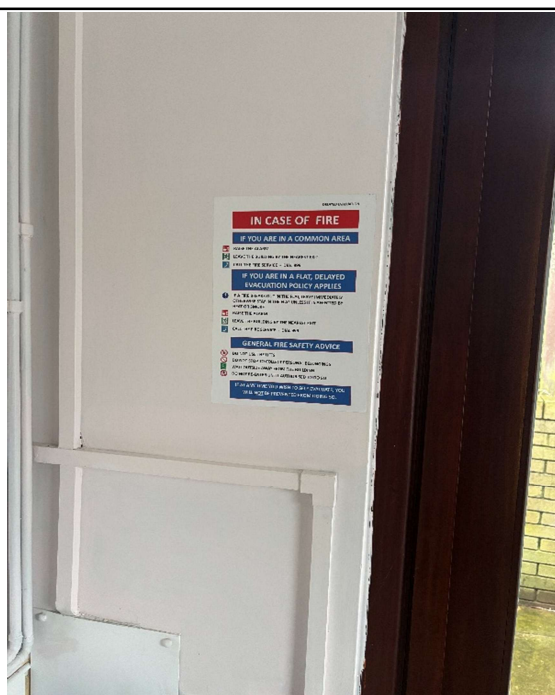
Photo No. 4

| 16.1 | Are the correct Fire Action/Advice notices displayed in prominent locations within the common areas? | Yes | The correct Notices are displayed throughout the scheme. | . | | |

Fire Notice.

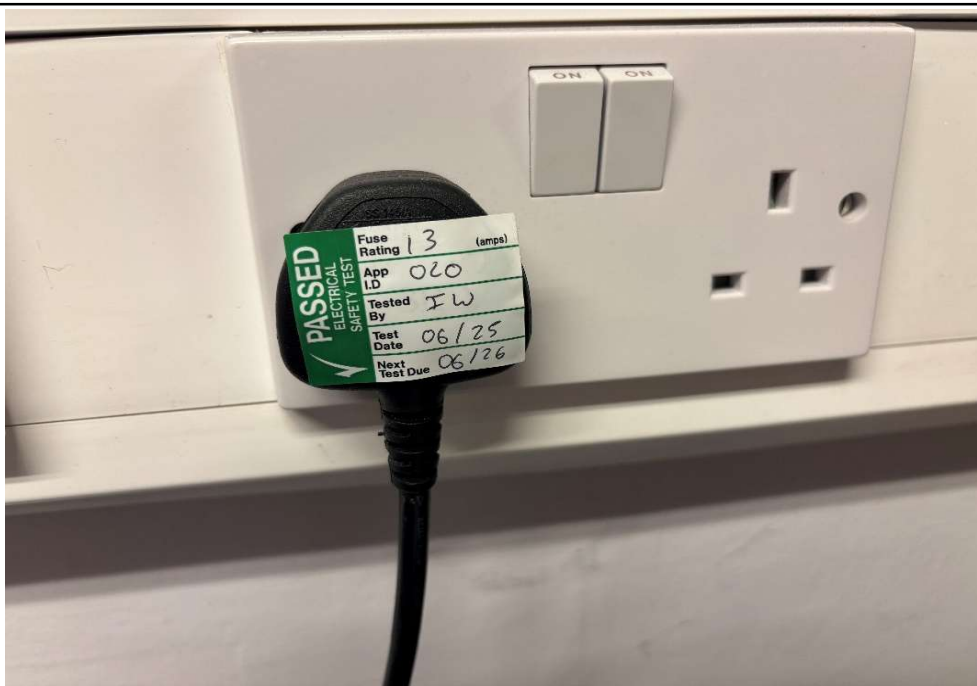
Photo No. 5

| Significant Findings - Fire | | | | | | |
|---|---|---|---|---|---|---|
| 1.4 | Electrical App/PA Testing - all portable appliances tested within past 12 months | Yes | Portable devices are PAT Tested, these include Office equipment and electrical equipment within the kitchen. | . | | |

Pat test cert.

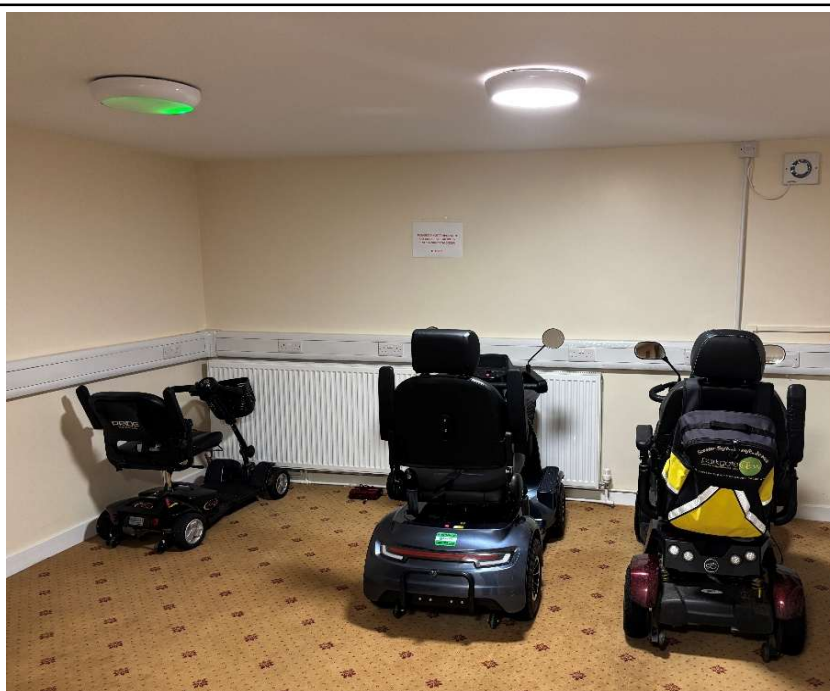
Photo No. 6

| Significant Findings - Fire | | | | | | |
|---|---|---|---|---|---|---|
| 1.6 | Mobility Scooters - Stored/charged in common areas, purpose built store/resident flat | Yes | There is a purpose built scooter store at this scheme. There were no scooters found within the communal areas at the time of inspection. The scooters are subjected to a PAT test annually. | . | | |

Scooter store

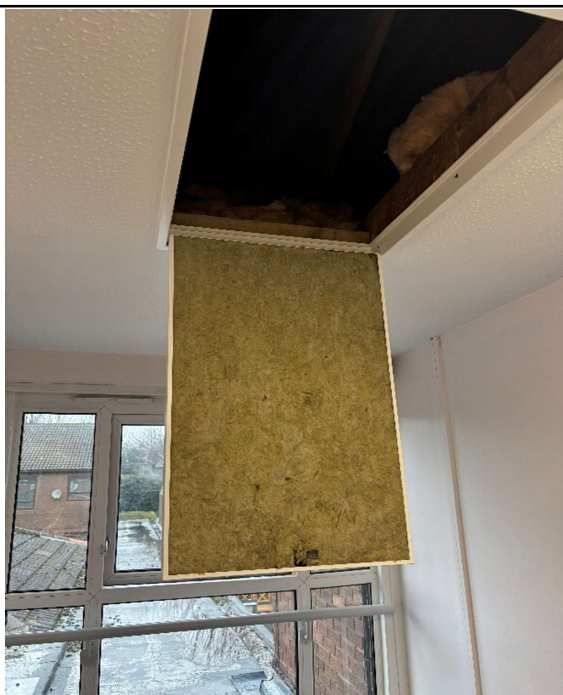
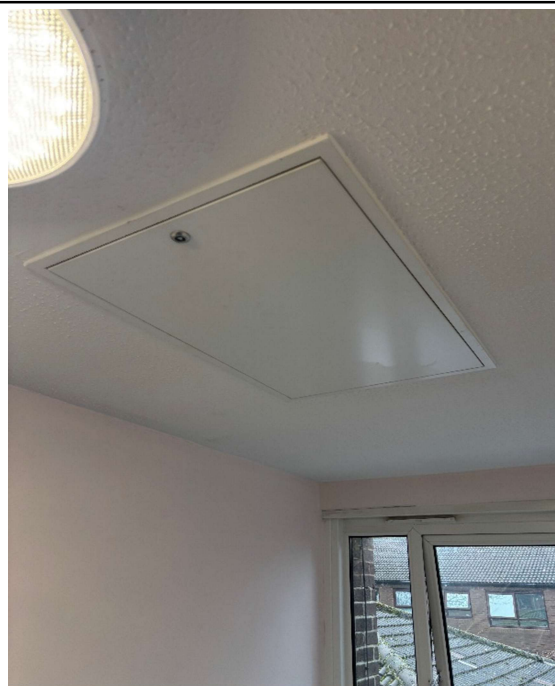
Photo No. 7

| 11.5 | Loft hatches fire resisting? | Yes | all Loft hatches are 1 Hour Fire rated | . | | |

1 Hour rated Loft Hatch.

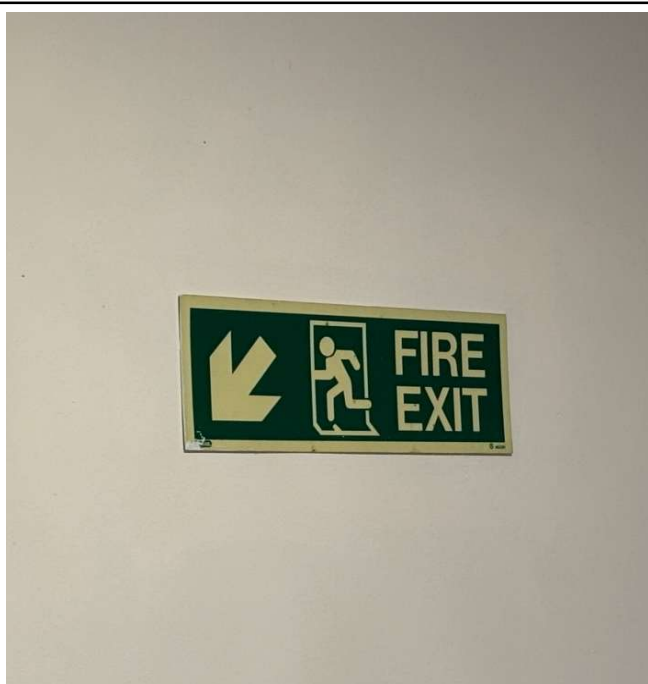
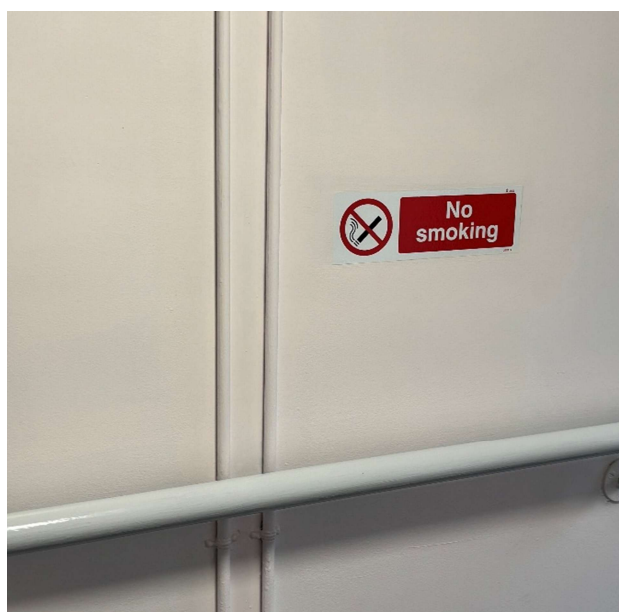
Photo No. 8

| 2.1 | Are there any risks associated with smoking in the building? | No | Smoking is not allowed within the communal areas. Smoking is only permitted within flats. There are smoking signs present within the communal areas. | . | | |

Directional escape and no Smoking signage throughout the Scheme

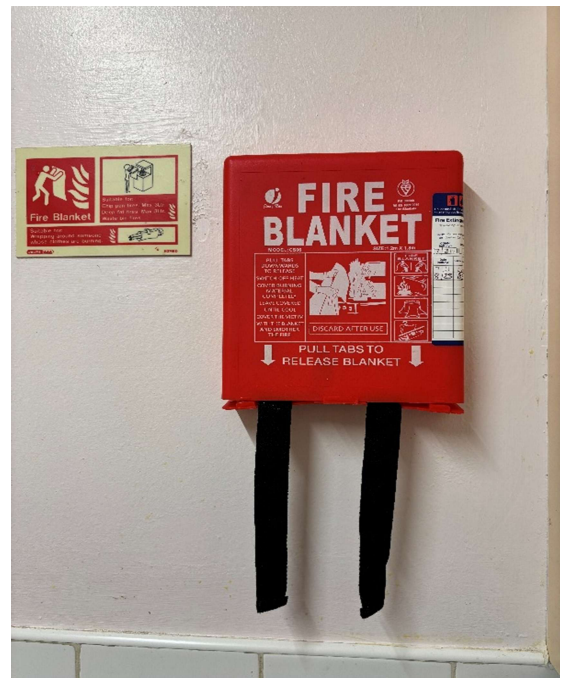
Photo No. 9

| 18.1 | Portable fire extinguishers - appropriate type/number/position? | Yes | Only provided in the high risk areas of the scheme. | . | | |
| 18.3 | Fire blanket in communal kitchen, secured to the wall, complete with signage? | Yes | | . | | |

Extinguisher and Fire Blanket, in date.
