## **ACCENT HOUSING - FIRE RISK ASSESSMENT**

| <b>Scheme Name :</b> | <b>55-60 The Martindales</b> |
| <b>Scheme Address :</b> | <b>The Martindales<br/>Clayton-Le-Woods<br/>PR6 7TJ</b> |
| <b>Date of Assessment:</b> | <b>9th Sept 26</b> |

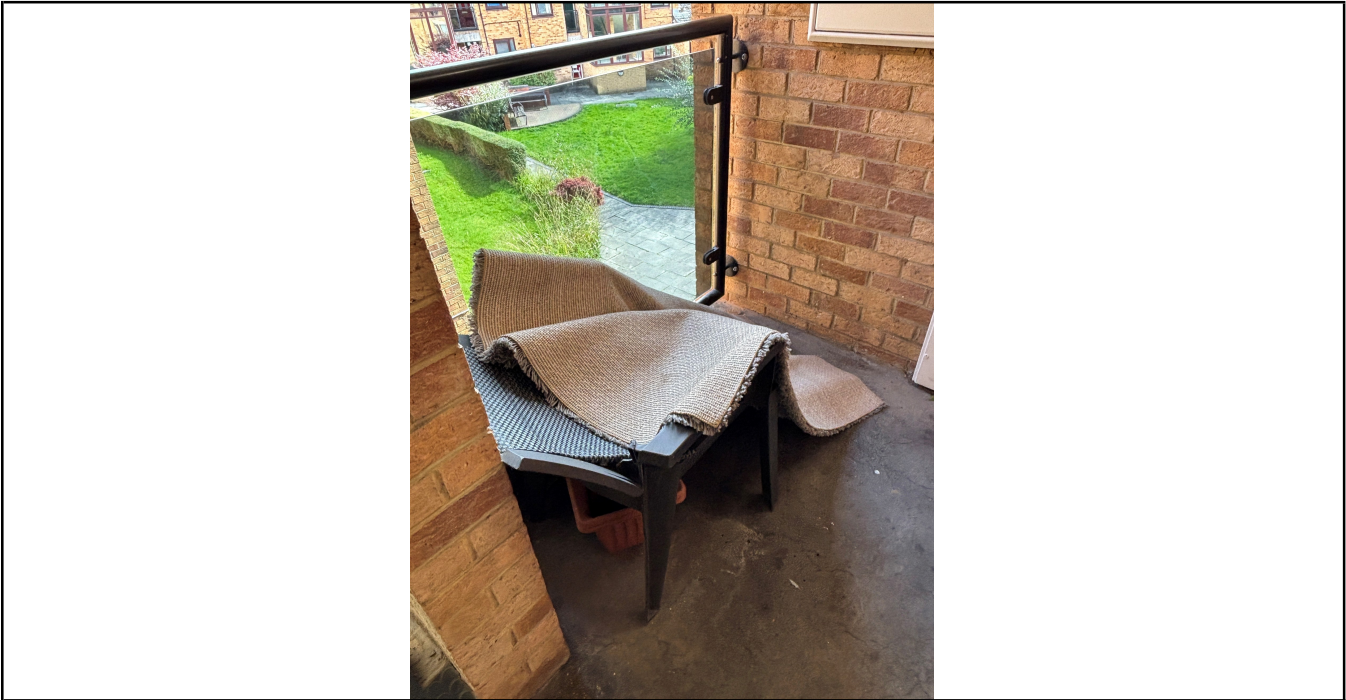
| Photo No. 1 | Personal items outside Flat 59 |

| 7.1 | Is the standard of housekeeping adequate? | No | Flammable personal items were found outside Flat 59. HP tasked to arrange removal. | Low | 30/9/26 |
| 7.4 | Are unnecessary accumulations of combustible materials or waste avoided? | No | See 7.1 | . | |

| Action Plan - Fire | | | | | |
|---|---|---|---|---|---|
| Is the standard of housekeeping adequate? | Flammable personal items were found outside Flat 59. HP tasked to arrange removal. | Low | 30/09/26 | Housing Partner | 2181413 |

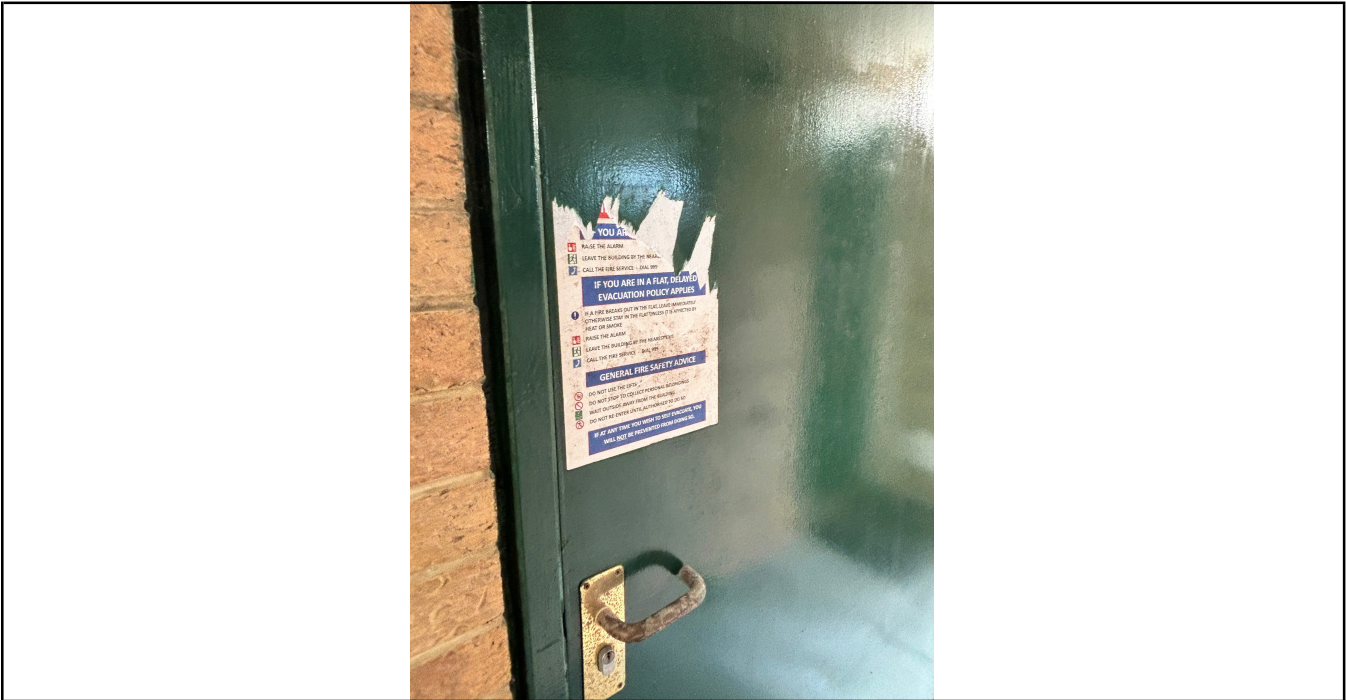
| Photo No. 2 | Fire evacuation notice torn - Replaced |

| 16.1 | Are the correct Fire Action/Advice notices displayed in prominent locations within the common areas? | No | Fire Evacuation notice was torn - replaced at time of inspection. | . | | |
