## ACCENT HOUSING - FIRE RISK ASSESSMENT

| <b>Scheme Name :</b> | <b>112 - 122 Church View</b> |
| <b>Date of Assessment:</b> | <b>14/08/2026</b> |

| Scheme Details | | 112 - 122 Church View |
|---|---|---|
| Scope of Assessment | | Type 1 (Common Parts Only - Non Destructive) |

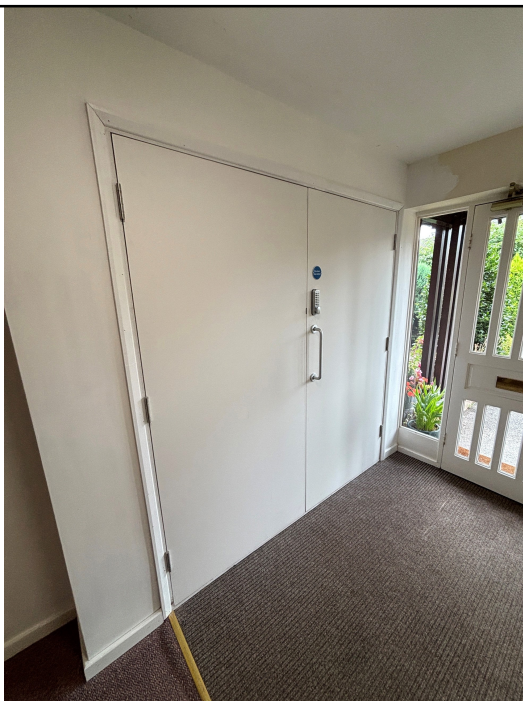
Photo No. 1

| 7.2 | Are all electrical/intake/service cupboards secure and free from general waste, contractors waste and residents personal items. | Yes | The Elecctrical cuboards were upgraded to 1 Hour fire rated doors last year. | . | | |

| 12.1 | Communal fire doors to FD30s standard and in a serviceable condition, | Other | The Fire door s within the communal area are the doors to the electrical cupboard which are 1 Hour fire rated | . | | |

1 Hour Fire doors newly installed

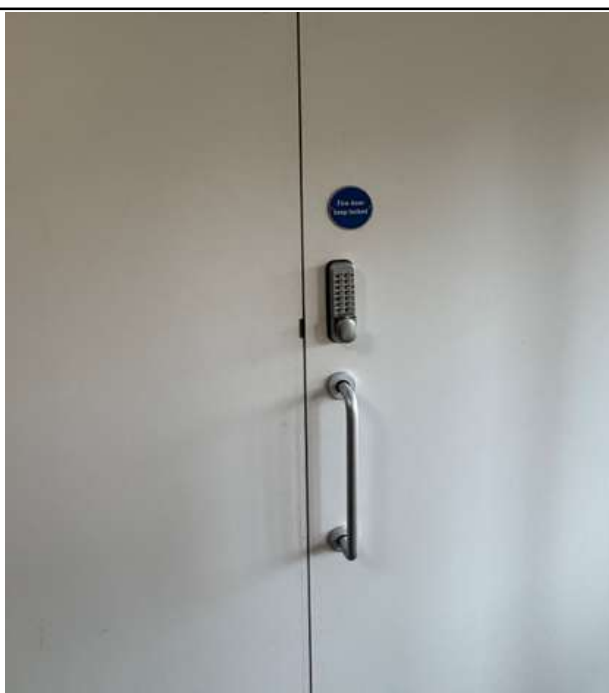
Photo No. 2

| 12.2 | "Fire door keep shut/locked" signage displayed on both sides of all applicable doors. | Yes | See Pictures | . | | |

Keep locked shut Signage

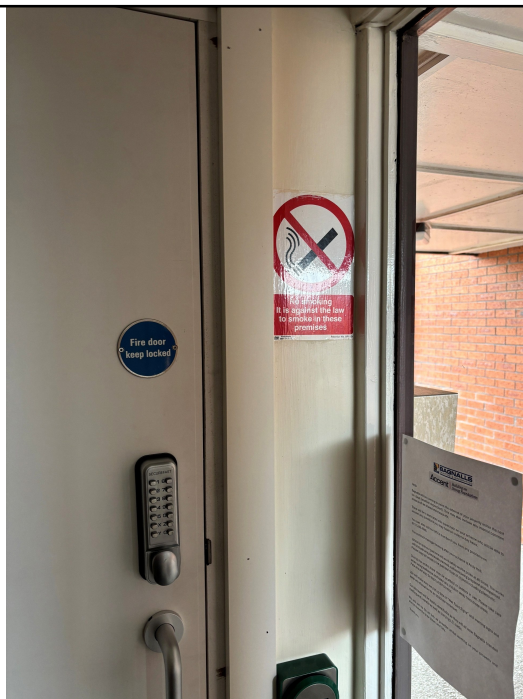
Photo No. 3

| Significant Findings - Fire | | | | | | |
|---|---|---|---|---|---|---|
| 2.1 | Are there any risks associated with smoking in the building? | No | Smoking is not allowed within the communal areas. Smoking is only permitted within flats. There are smoking signs present within the communal areas. | . | | |

No Smoking Signage throughout the scheme

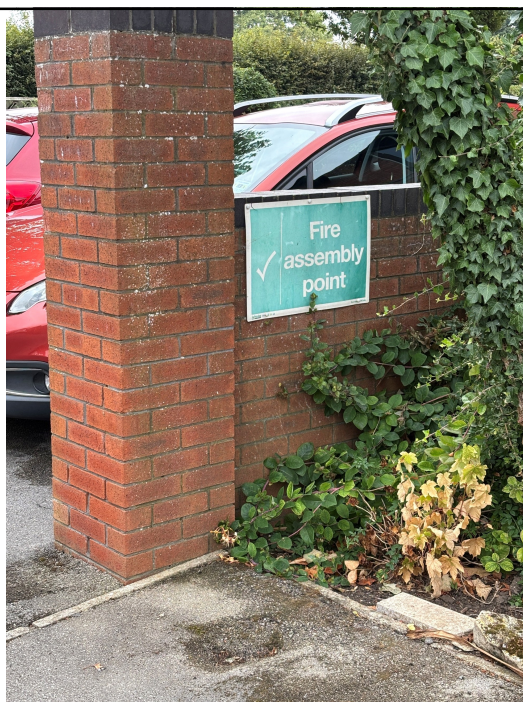
Photo No. 4

| 19.7 | Offices/IL Schemes - Is there a suitable assembly point? | Yes | In the car park near main entrance. | . | | |

Fire Assembly Point by the car park

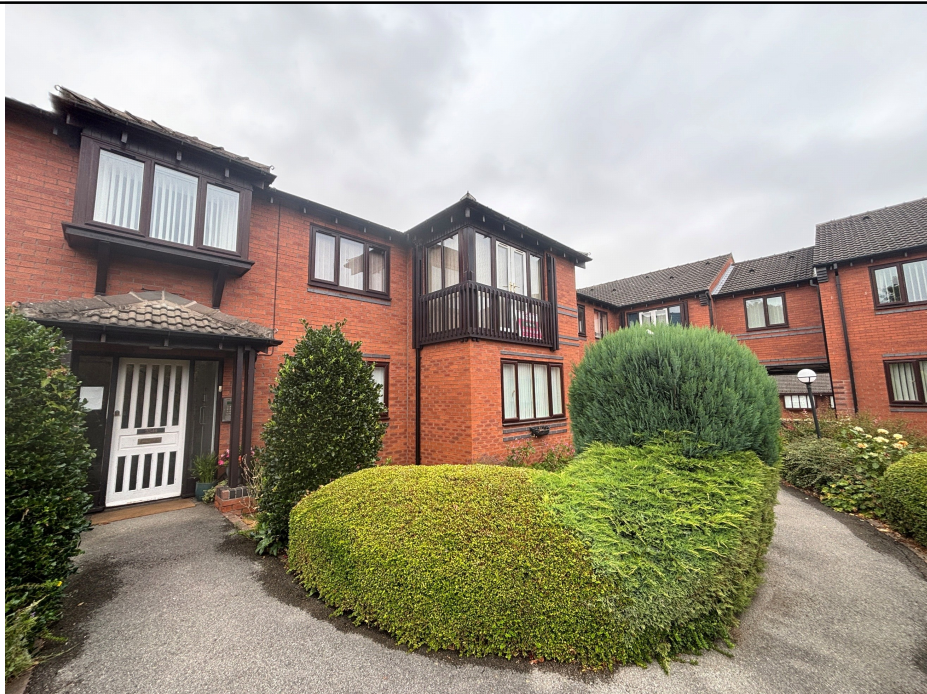
Photo No. 6

Flats have a Juliet balcony with a wooden rail

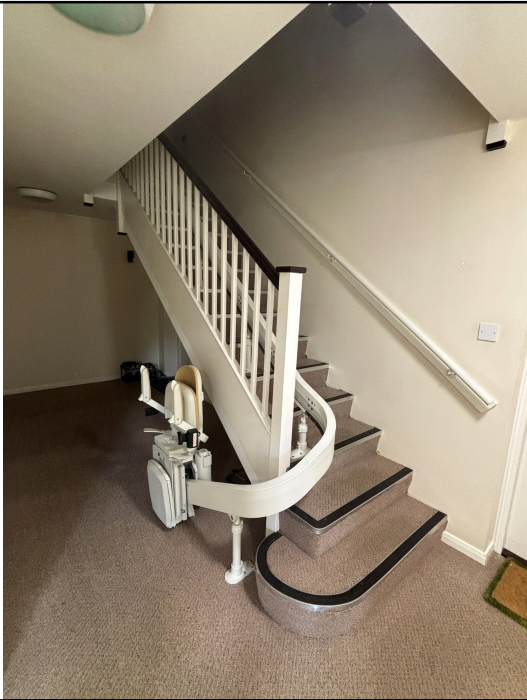
| Photo No. 7 | Stairlift to first floor not used in fire evacuation. |
