This report shows all the responses to the Fire Risk Assessment survey , including raised tasks.

Asset ID: 45 Addington Court, Nottingham

| Purpose of Fire Risk Assessment | 3 year Re-Assessment |
| Type of Fire Risk Assessment | Type 1 (Common Parts Only - Non Destructive) |

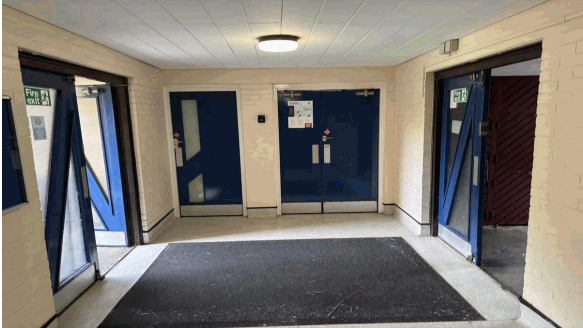
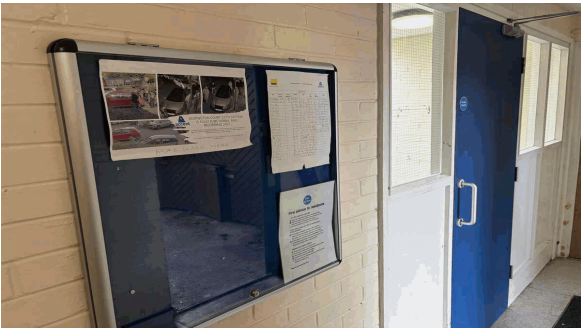
Comment

Do common area fire doors display the correct signage on both sides where applicable?

Yes

| Observation | Priority | Referred To | Required By: | Task ID |
|---|---|---|---|---|
| Replace and install. | Internal - Low | Housing Partner | | |
