## ACCENT HOUSING - FIRE RISK ASSESSMENT

| <b>Scheme Name :</b> | <b>Whitley Court</b> |
| <b>Scheme Address :</b> | <b>1-36 Whitley Court, Grosvenor Road.<br/>Aldershot<br/>GU11 1DL</b> |
| <b>Date of Assessment:</b> | <b>05/02/2026</b> |

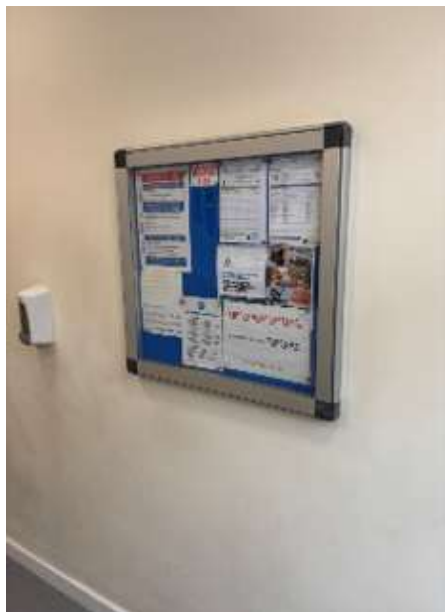
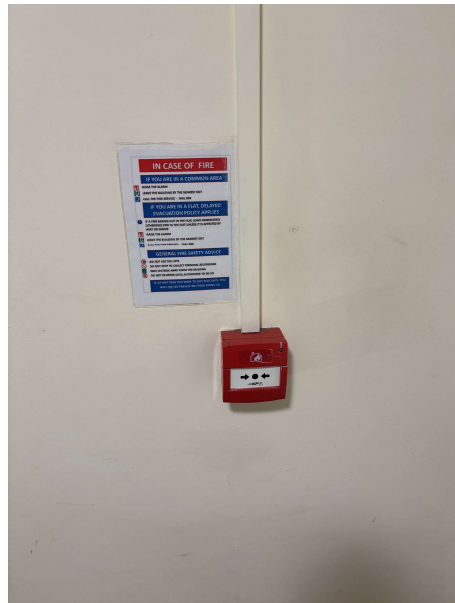
Photo No. 1

Evacuation notice posted throughout the building.

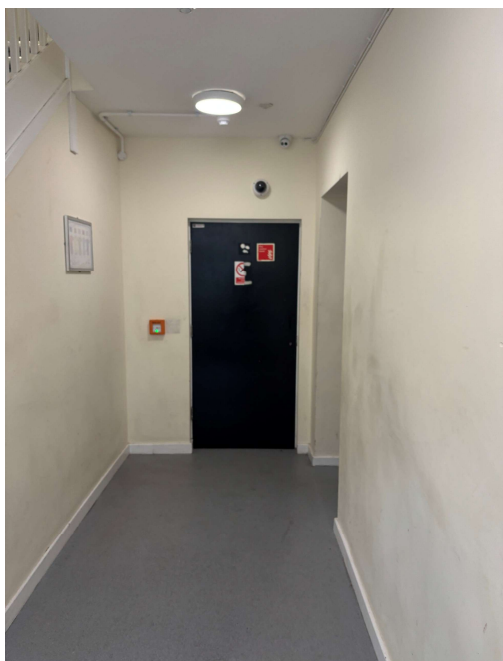
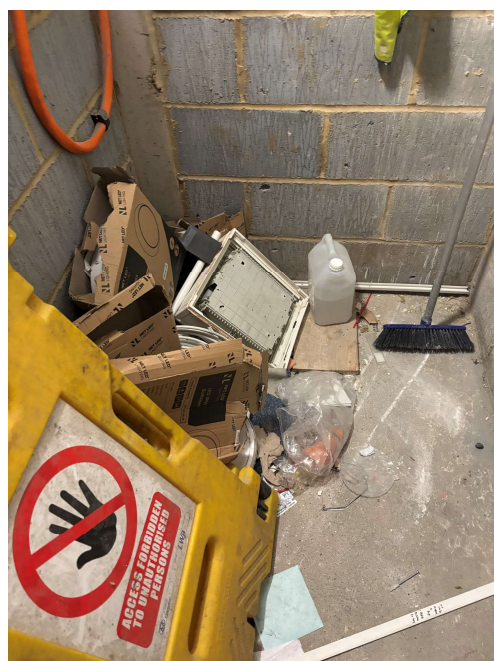
Photo No. 2

| 7.1 | Is the standard of housekeeping adequate? | No | Items of rubbish building up outside flat 9. Fly tipping in the rear stairwell, contractors rubbish in the electrical intake cupboard and slip hazard in the communal courtyard. HP Dealing with all noted issues. | . | |
| 7.2 | Are all electrical/intake/service cupboards secure and free from general waste, contractors waste and residents personal items. | No | See note 7.1 | . | |

Contractors waste in the electrical intake cupboard.

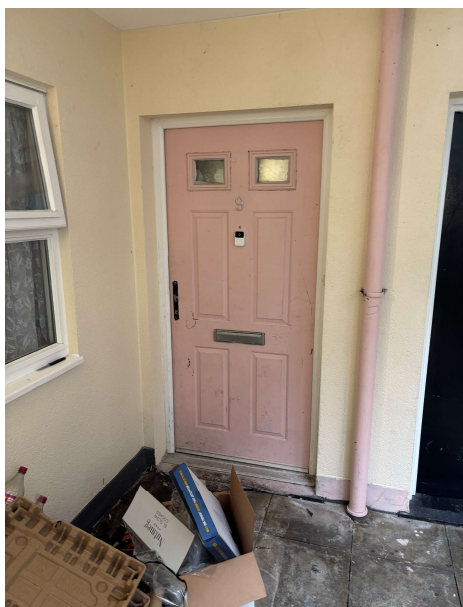
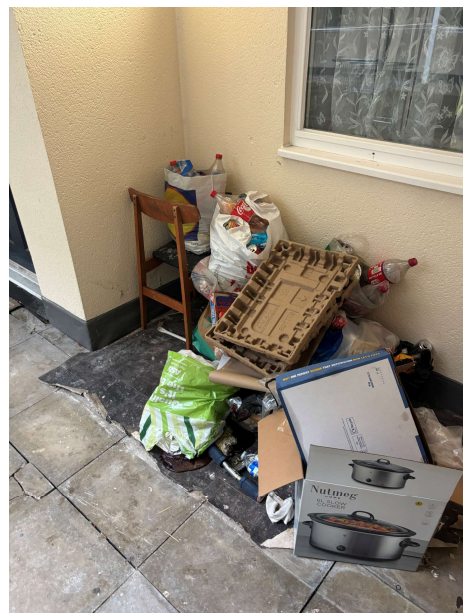
Photo No. 3

Rubbish requires removing from outside flat 9.

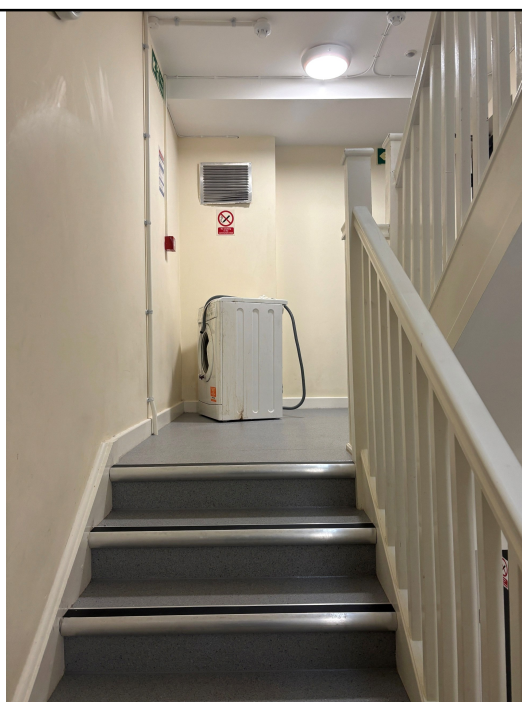
Photo No. 4

| 10.2 | Escape routes unobstructed and safe to use? | No | Fly tipping in the rear stairwell. | . | | |

Washing Machine fly tipped in the rear stairwell 3rd/4th floor.

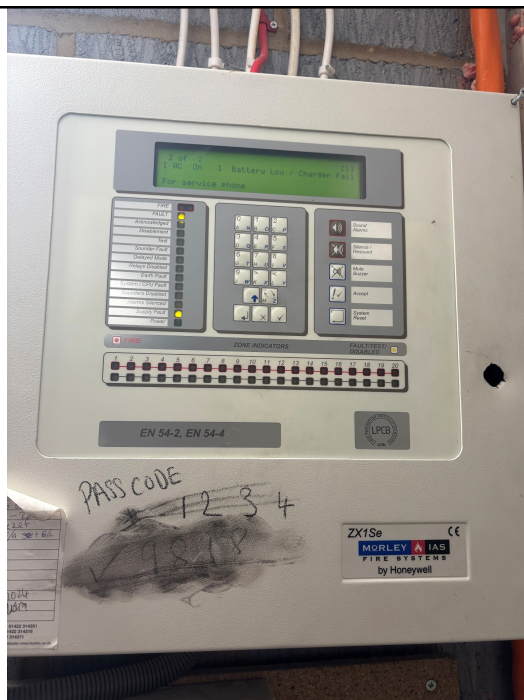
Photo No. 5

Fault showing on the alarm panel.

| 17.3 | Is the fire detection and warning system maintained/tested and all certificates saved on file. (BS 5839-1:2017) | Yes | The fire alarm panel was showing a fault. This was reported and cleared by Tunstall following the audit. | . | | |

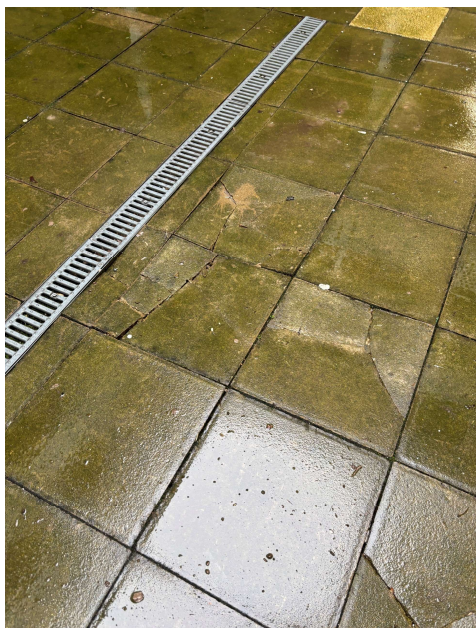
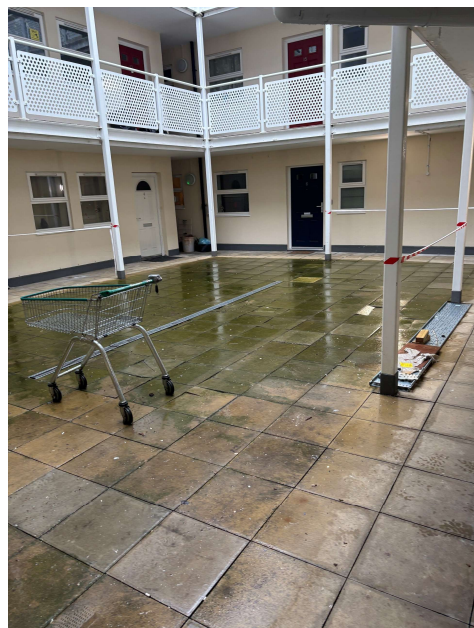
Photo No. 6

Communal courtyard paving slabs require cleaning off.

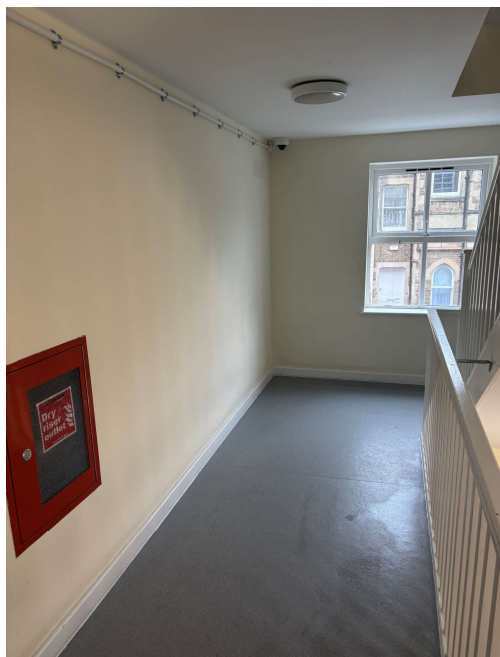
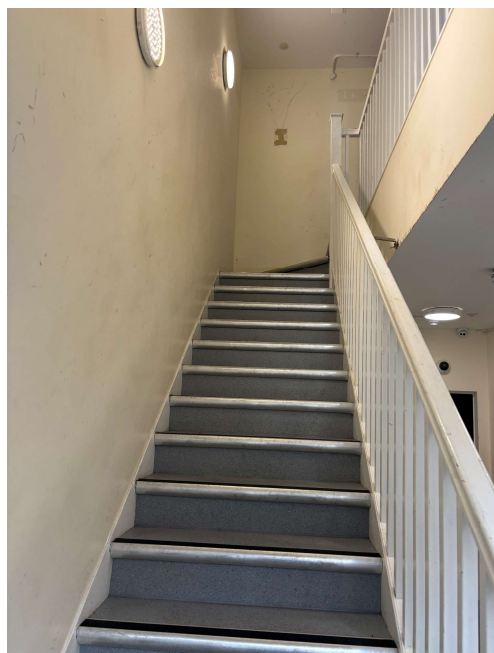
Photo No. 7

| 16.1 | Are the correct Fire Action/Advice notices displayed in prominent locations within the common areas? | No | All singage has been removed form the front communal stairwells and require replacing. GB dealing. | . | | |
| 16.3 | Directional fire escape signage in place and adequate? | No | All singage has been removed form the front communal stairwells and require replacing. GB dealing. | . | | |

All wayfinding singage has been removed from the front stairwell.

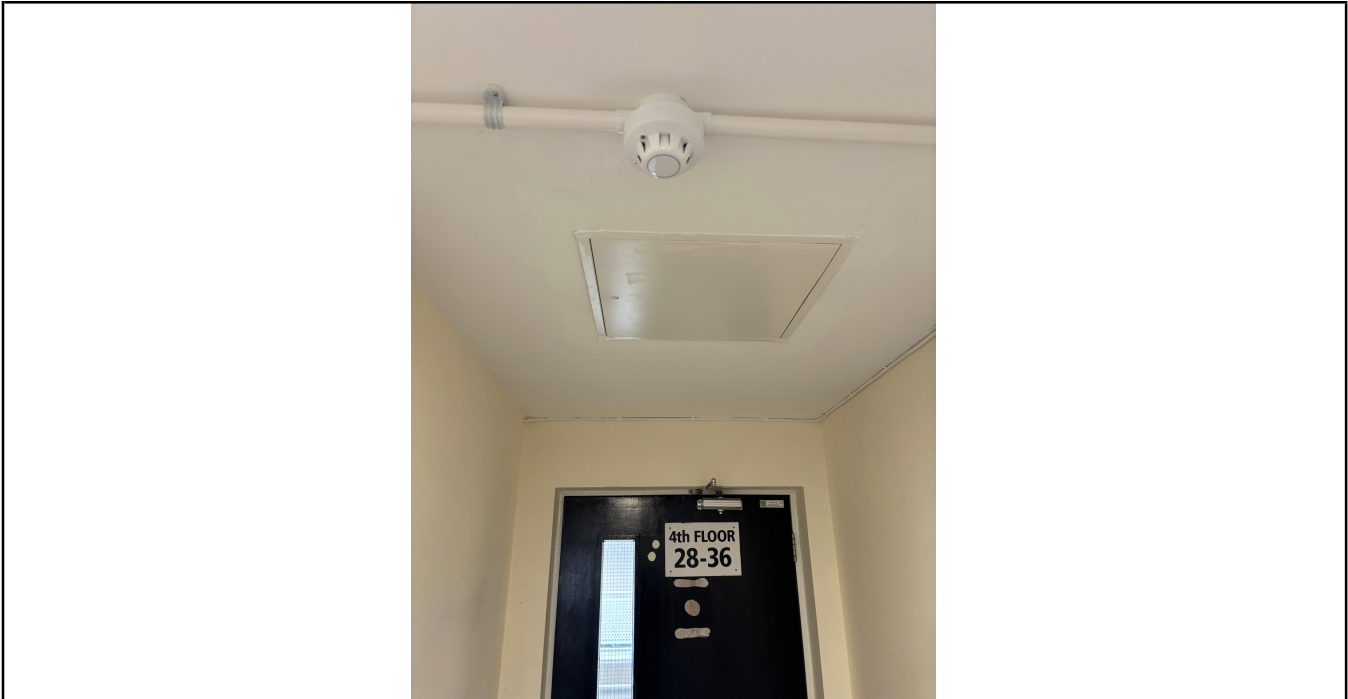
| Photo No. 9 | The loft hatch is of metal construction and complies to the latest standards |

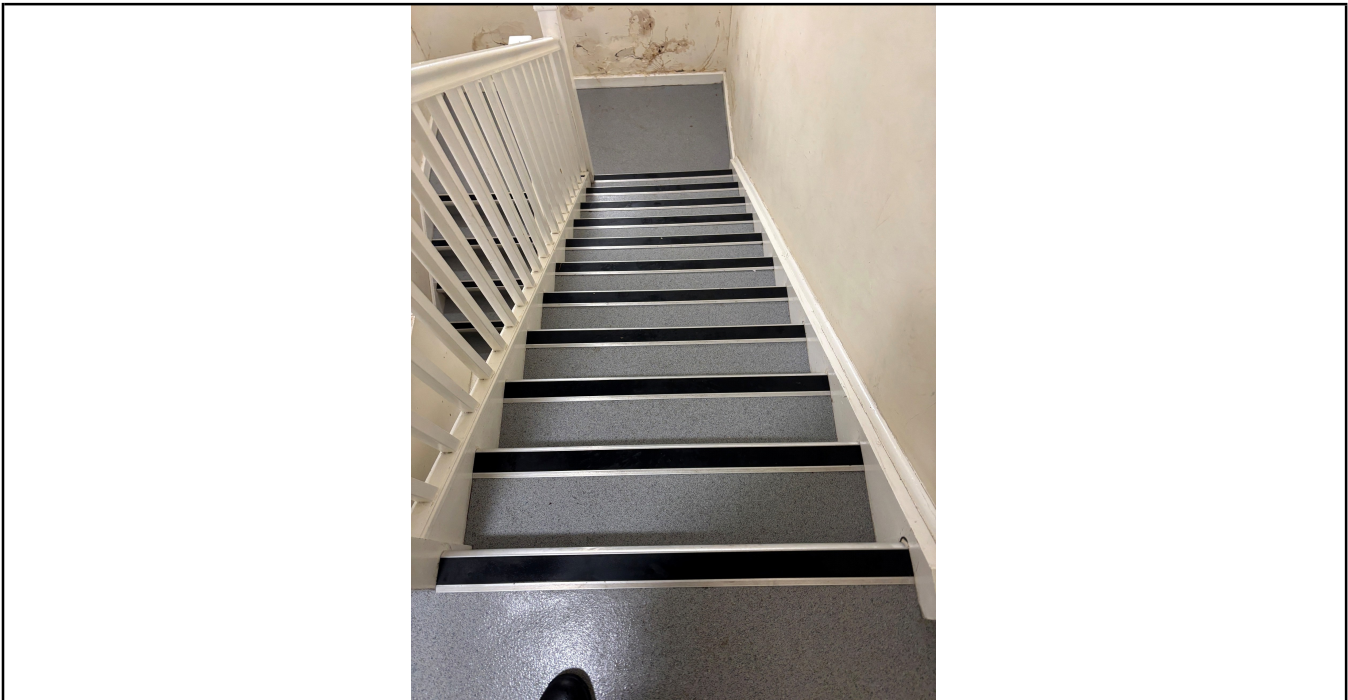
| Photo No. 10 | All risers and nosings were in good condition during the audit. |

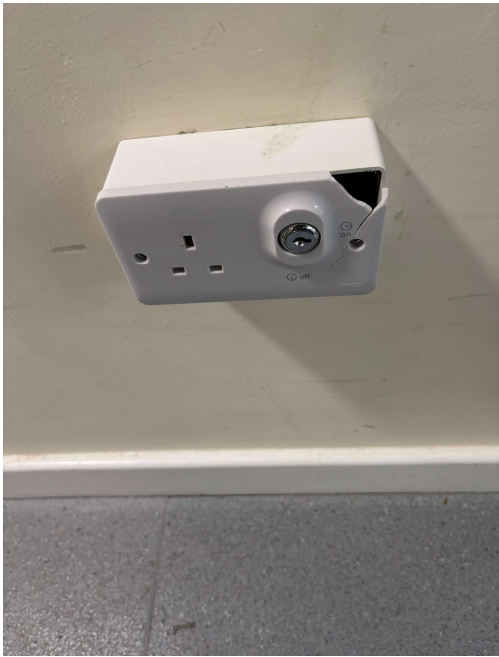
| Significant Findings - Fire | | | | | | |
|---|---|---|---|---|---|---|
| 1.1 | Electrical Installation within common areas (Fixed Wiring, sockets, switches, light fittings) in good condition and no obvious damage | No | Double socket on the front stairwell 4th floor is broken and requires replacing. Job raised 1352137. | . | | |

| Photo No. 11 | Double socket broken on the 4th floor. |
