# Fire Risk Assessment Report

**Asset ID: 197**      **Century Square, Peterborough**

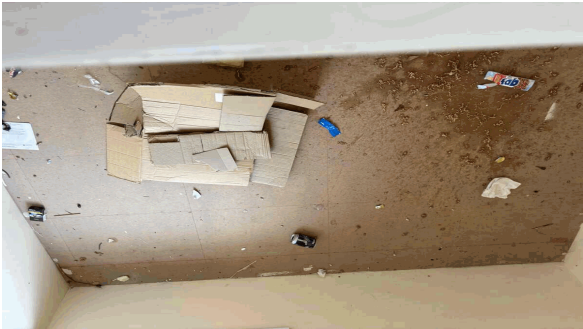
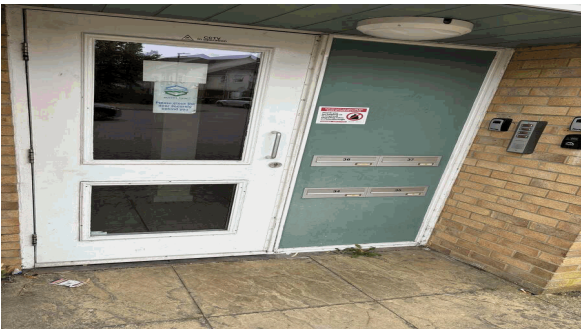
| Observation | Priority | Referred To | Required By: | Task ID |
|---|---|---|---|---|
| First floor lobby area | Internal - Low | Housing Partner | | |
