## ACCENT HOUSING - FIRE RISK ASSESSMENT

| <b>Scheme Name :</b> | <b>40-50 Ringstead Road</b> |
| <b>Date of Assessment:</b> | <b>19/03/2026</b> |

| Scheme Details | | 40-50 Ringstead Road |
|---|---|---|
| Scope of Assessment | | Type 1 (Common Parts Only - Non Destructive) |

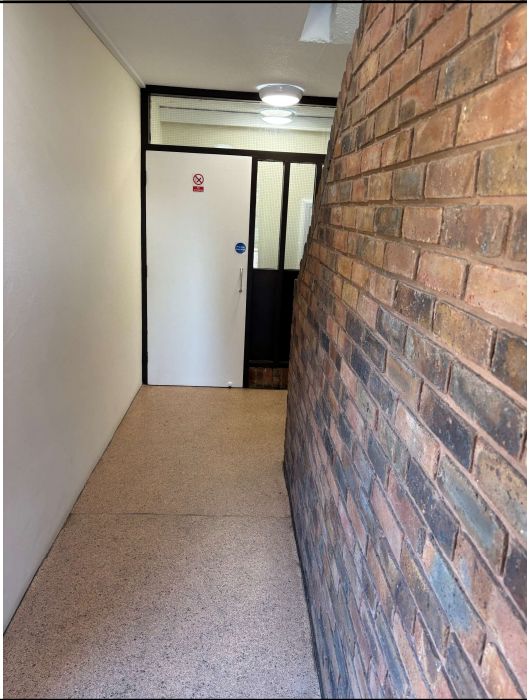
Photo No. 1

Ground Floor Entry Communal area and smoke lobby Partition Georgian Glass and communal Fire Door.

| 11.1 | Is it considered that the compartmentation is of a reasonable standard? | Yes | Smoke lobby areas on ground Floor and First Floor with Communal Fire Doors. | . | | |

| 12.1 | Communal fire doors to FD30s standard and in a serviceable condition, | Yes | There are communal smoke lobby partition with georgian wire and a Communal Fire Door on ground and First Floor. | . | | |

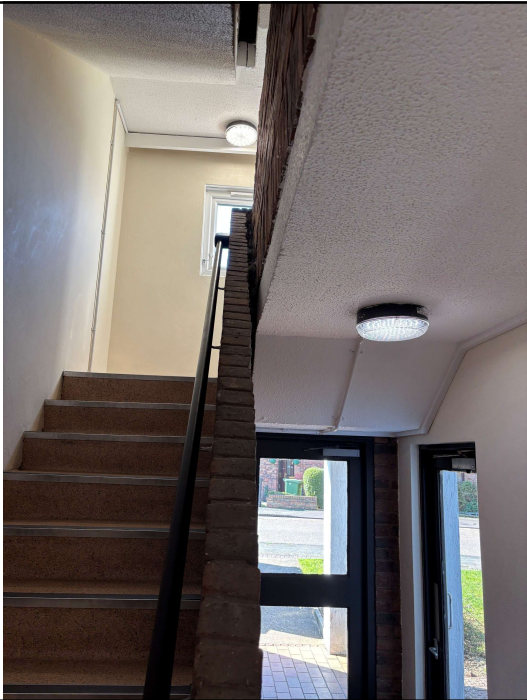
Photo No. 2

Ground to First Floor Communal area.

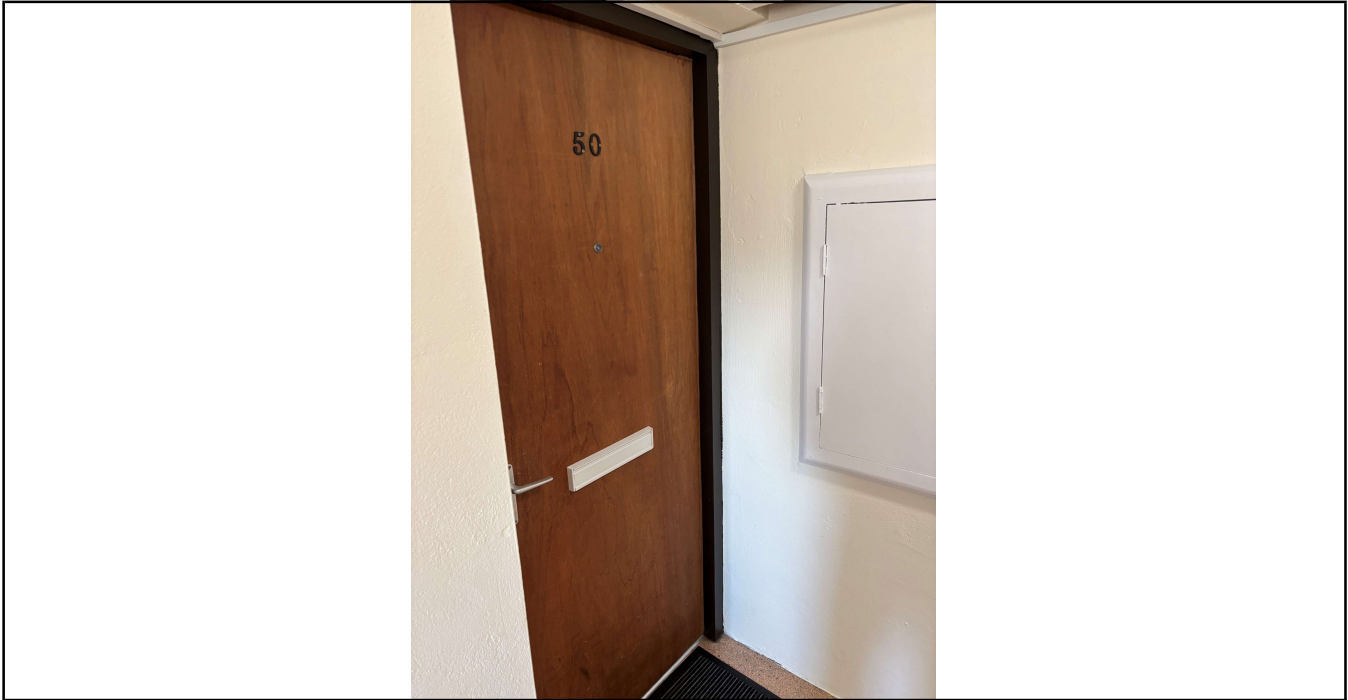
| Photo No. 3 | Standard Flat Door and utilities secure cupboard. |

| 7.2 | Are all electrical/intake/service cupboards secure and free from general waste, contractors waste and residents personal items. | Yes | The Electrical in takes are adjacent to the flats and are secure. | . | | |

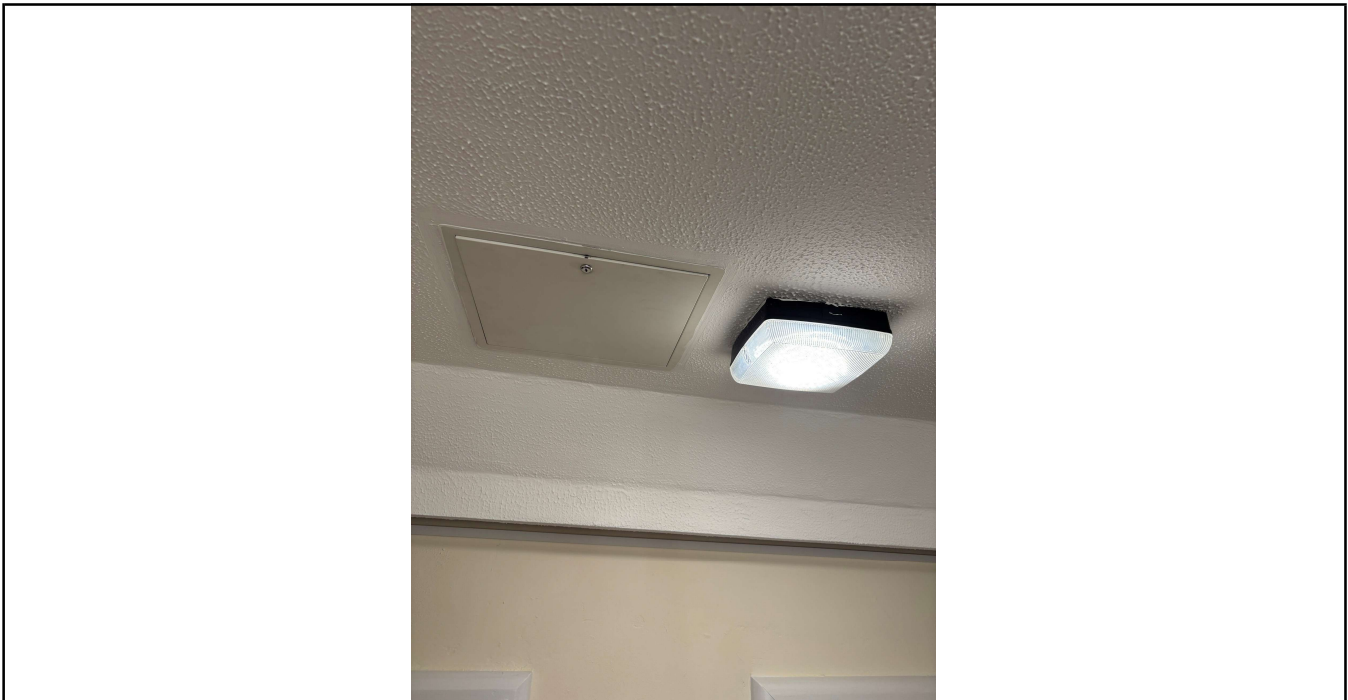
| Photo No. 4 | Top Floor which has no smoke lobby, Fire resistant loft hatch<br>Maintained EML. |

| 11.5 | Loft hatches fire resisting? | Yes | Loft hatch 1 Hr Fire resisting Hatch in top floor communal area. | . | | |

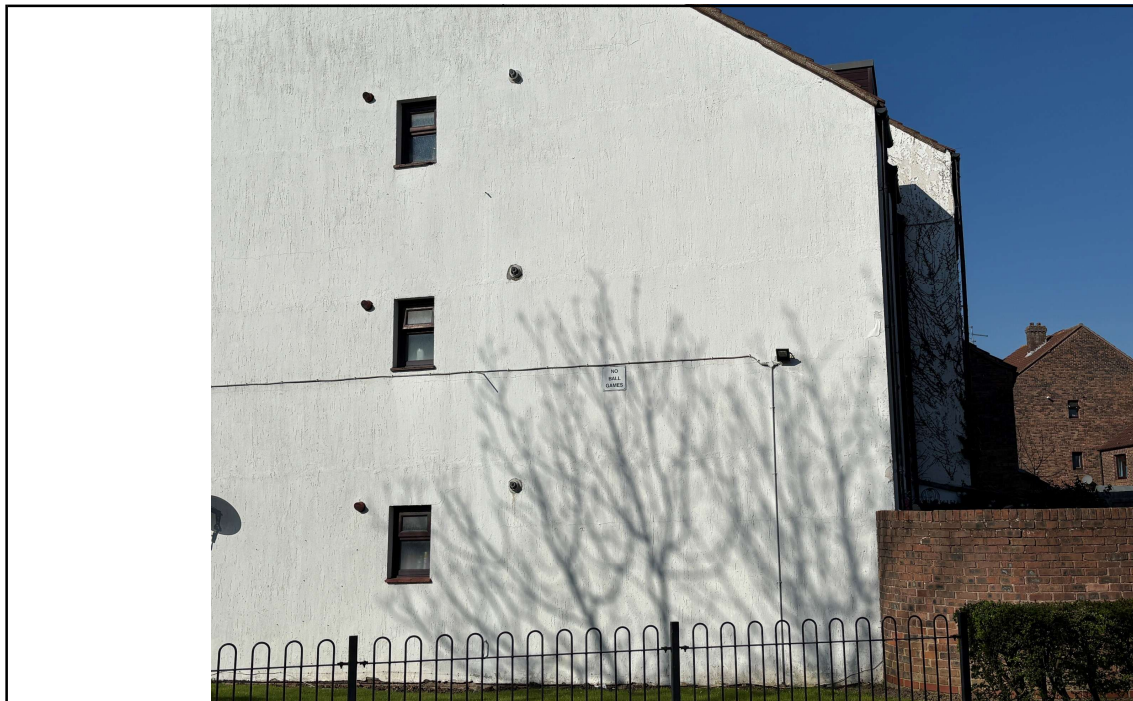
Photo No. 5

External side and rear view of the building.
