This report shows all the responses to the Fire Risk Assessment survey , including raised tasks.

**Asset ID:** 24622      **Deanside**

Fire Risk Assessment Survey Results

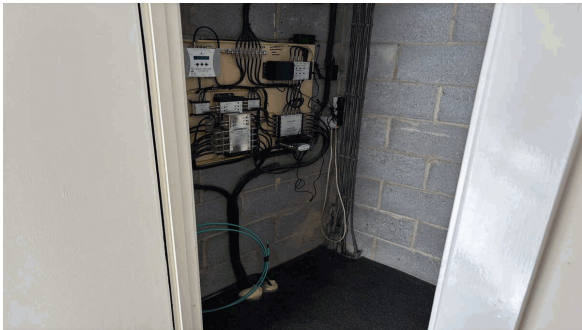
| Observation | Priority | Referred To | Required By: | Task ID |
|---|---|---|---|---|
| All electrical cupboards were found to be clear at the time of the audit. | | | | |

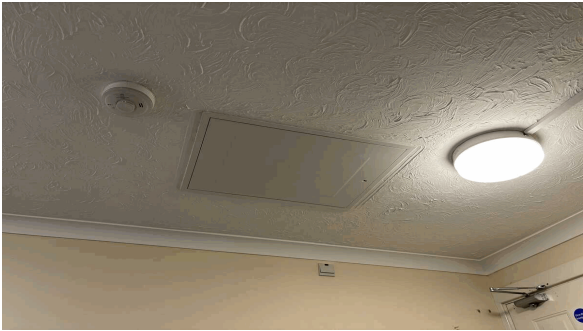
| Observation | Priority | Referred To | Required By: | Task ID |
|---|---|---|---|---|
| All loft hatches comply to the latest FR Standards. | | | | |

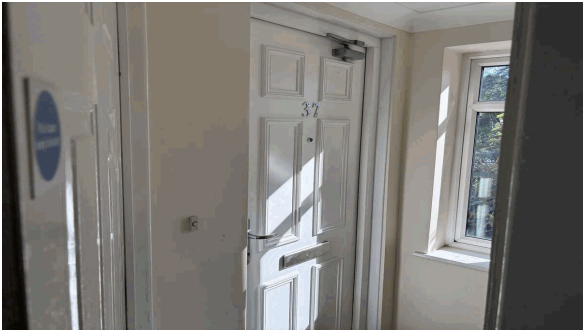
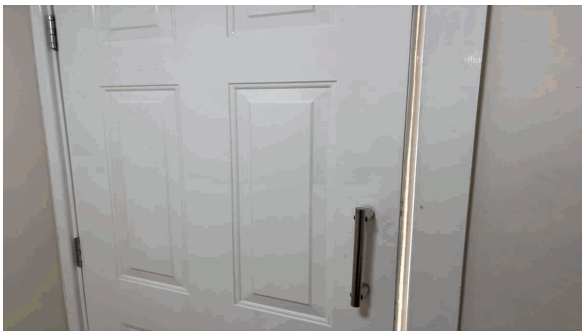
| Comment | 2 x Cross corridor doors in block 35-41 do not close on there frames as designed. These require ease and adjusting. Job raised 1316150 |

| Observation | Priority | Referred To | Required By: | Task ID |
|---|---|---|---|---|
| Block 35-49 cross corridor doors do not close in there frame as designed. These require ease and adjusting. Job raised.131650. | Internal - Medium | | | |

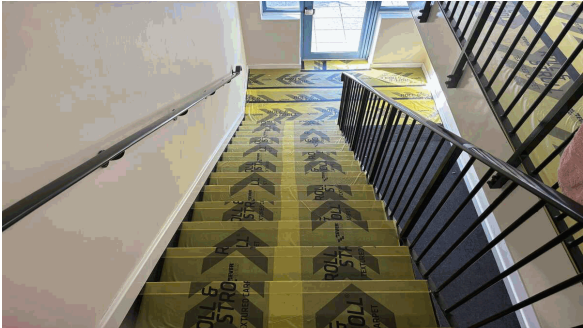
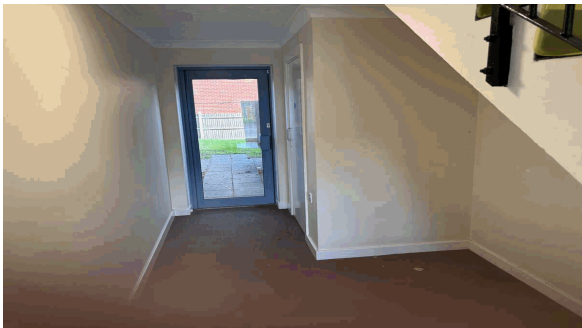
| Observation | Priority | Referred To | Required By: | Task ID |
|---|---|---|---|---|
| All areas were found to be clear at the time of the audit. | | | | |

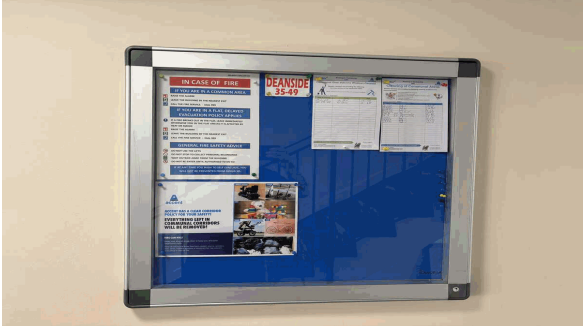
| Observation | Priority | Referred To | Required By: | Task ID |
|---|---|---|---|---|
| Evacuation policy is posted in every block audited. | | | | |

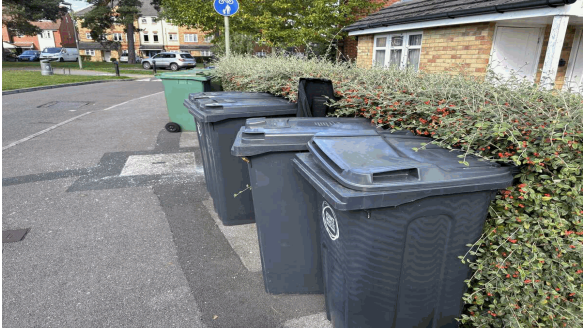
| Observation | Priority | Referred To | Required By: | Task ID |
|---|---|---|---|---|
| All bins were located outside the front or rear of the buildings at an acceptable distance. | | | | |

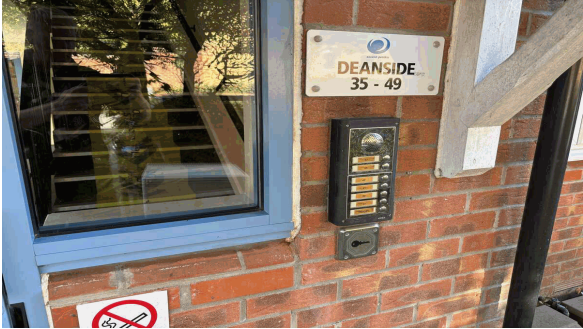
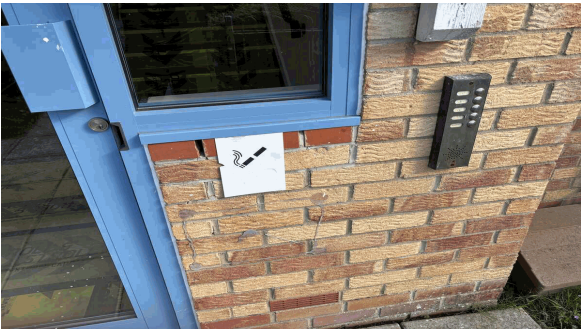
| Observation | Priority | Referred To | Required By: | Task ID |
|---|---|---|---|---|
| Electronic door entry system in place for security reasons. | | | | |
