This report shows all the responses to the Fire Risk Assessment survey, including raised tasks.

**107 Dyehouse Lane Block 1-6 Dyehouse Lane, High Peak**

## Cover Sheet

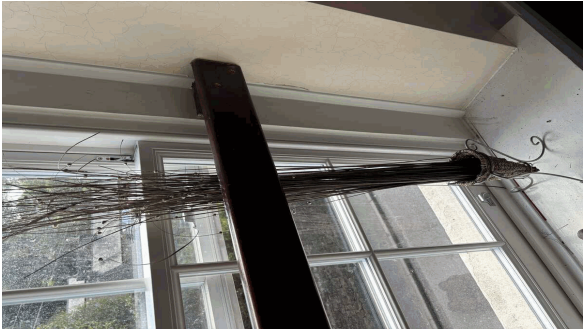
| Comment | Dried grasses on display in communal staircase |

| Observation | Priority | Referred To | Required By: | Task ID |
|---|---|---|---|---|
| A vase of dried grasses were found in the communal staircase. These require removing as they present a combustibile substance on the escape route | Internal - Low | | | |

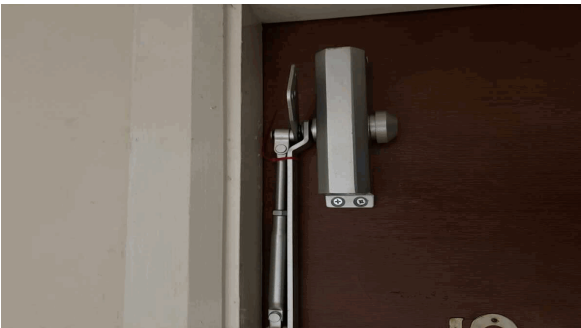
| Comment | From what could be observed from the corridor and from the loft opening. The compartmentation from the 2nd floor above flats 5 and 6 does not extend into the loft space. This is not required under LACORS guidance for this height and age of the building.<br>All fire doors are nominal doors and appear to be of substantial wooden construction in excess of the required 44mm with intumescent strips and smoke seals but no visible test certification on the door or hinges. Only one door was checked due to access. Door 5 appeared to be damaged and the self closer was disconnected |

| Observation | Priority | Referred To | Required By: | Task ID |
|---|---|---|---|---|
| The Flat front door to No5 appeared damaged and had the self closing device disconnected. Housing partner to inform resident who owns the door to ensure it is repaired | Internal - Medium | | | |
