This report shows all the responses to the Fire Risk Assessment survey , including raised tasks.

Asset ID: 8936 4 Nelson Street Block 1-12 Nelson Street, Dewsbury

Cover Sheet

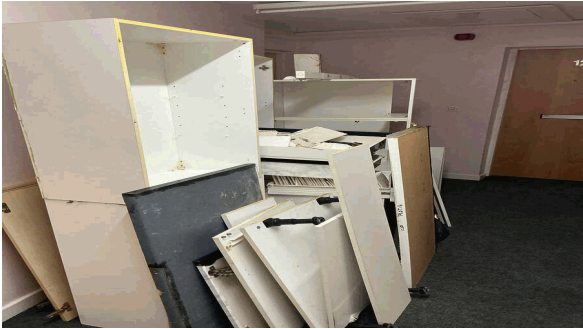
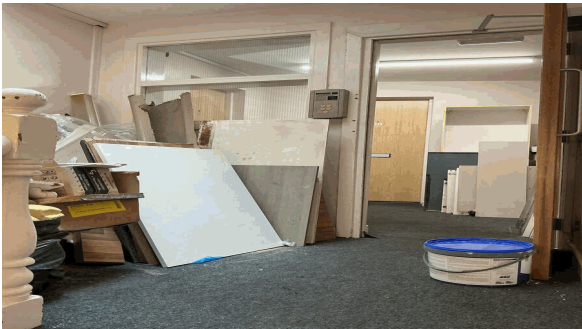
There are some items outside flat number 4, the HP is aware and will deal. A large amount of kitchen cupboards and waste were obstructing means of escape on the top floor. Kitchen contractors are aware and have removed the rubbish. See observations.

Observation	Priority	Referred To	Required By:	Task ID
Kitchens and other combustibles outside flats 9, 10, 11, and 12. Contractor has been informed and has cleared the items.	Internal - High			
<div>

Is it considered that the building is provided with reasonable means of escape in case of fire?	Yes
Comment	There is a single stairway to the building, with protected lobby's on each floor.
Escape routes unobstructed and safe to use?	Yes
Comment	After the contractors removed there debris from installing new kitchens. They have been told to clear up as they go.

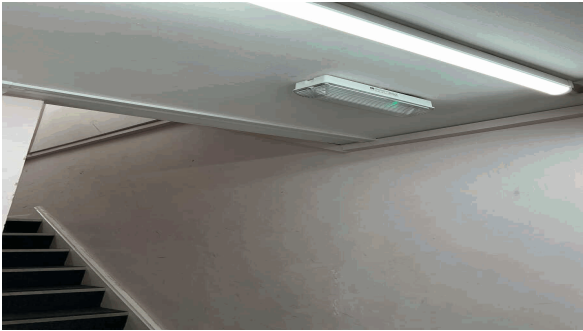
Is the emergency lighting correctly specified and installed as per current standards?	Yes
Comment	
Emergency lighting units in good condition and securely fixed to walls/ceilings?	Yes
Comment	All in good condition at the time of inspection.
Records of monthly/annual testing available?	Yes
Comment	All records can be found on ActiveH Last test. Last test dates. Monthly : - 14/07/2025 Annual : - 16/09/2024

Observation	Priority	Referred To	Required By:	Task ID
None maintained Emergency Lighting

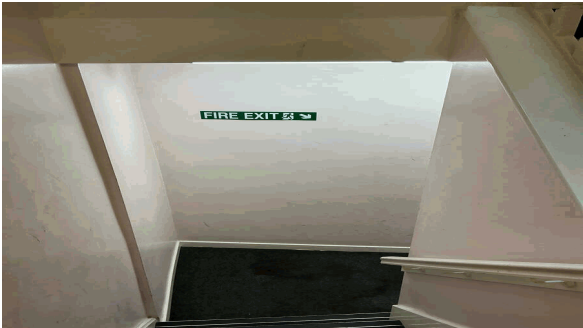
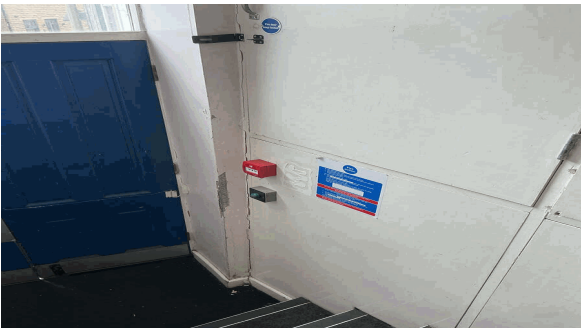
Fire evacuation and exit signs.

Are the correct Fire Action/Advice notices displayed in prominent locations within the common areas?	Yes
Comment	signage provided and present throughout the at the time of inspection.
Directional fire escape signage in place and adequate?	Yes
Comment	There is only one direction of travel but it is clearly marked, see observations.
Is there suitable LIFT signage i.e. do not use in case of fire?	N/A
Comment	None fitted.
Do common area fire doors display the correct signage on both sides where applicable?	Yes
Comment

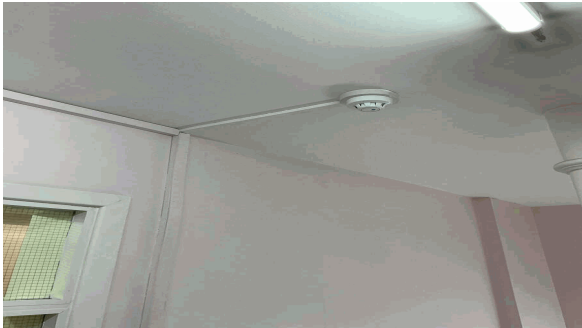
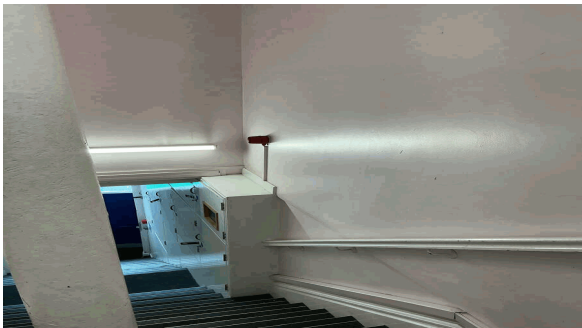
Detection and sounders

Is the scheme fitted with a communal area fire alarm?	Yes
Comment	
Is fire detection and warning system appropriate for occupancy and fire risk, as per BS 5839-1:2017?	Yes
Comment	
Is the fire detection and warning system maintained/tested and all certificates saved on file?	Yes
Comment	The alarm is tested by Tunstall. All records are available on ActiveH Last test Last Teast dates. Weekly : -21/07/2025 6 Monthly : - 24/02/2025
Fire alarm components in good condition and securely fixed to walls/ceilings?	No
Comment	All in good at the time of inspection.
Hold open devices operate at the sounding of the alarm and are in a serviceable condition?	N/A
Comment	None fitted
Are there heat detectors located in the Kitchen, Boiler, Plant Room and Laundry?	N/A
Comment	
Is the fire alarm panel remotely monitored, and if so are there records of regular testing?	No
Comment

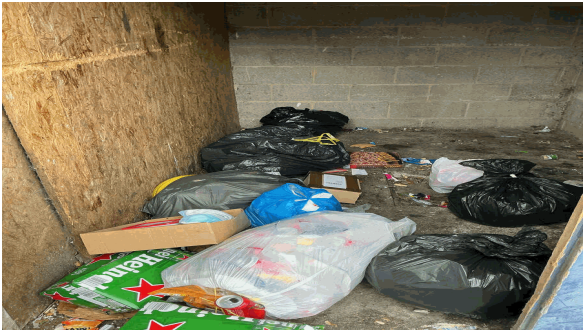
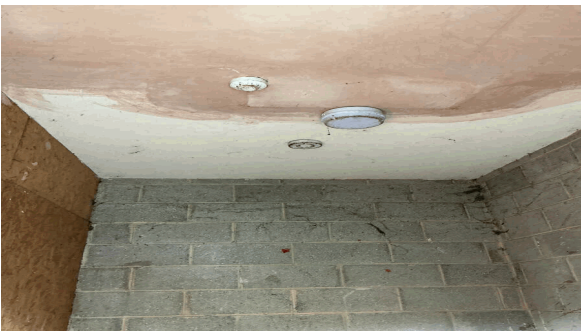
The bin storage area is accessed from outside, the bins were on the curb awaiting at the time of inspection. Some rubbish was still within the bin area, HP informed.

Observation	Priority	Referred To	Required By:	Task ID
Bin store needs emptying	Internal - Low	Housing Partner
