**Asset ID: 682**      **18-21 Cogenhoe Walk Block 18-21, Nottingham**

| Type of Fire Risk Assessment | Type 1 (Common Parts Only - Non Destructive) |

# Fire Risk Assessment Survey Results

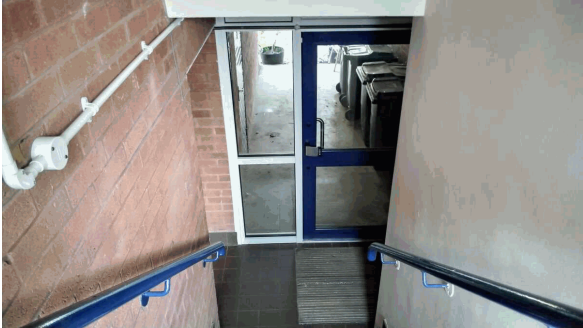
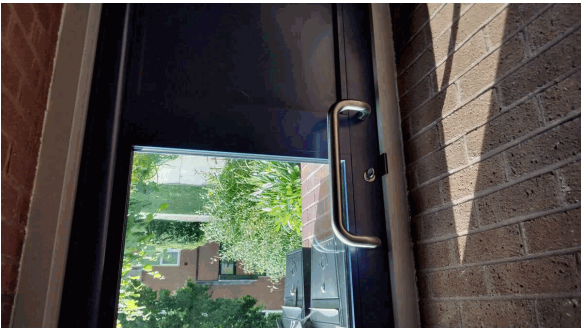
New final exit doors and communal door has been upgraded to meet the means of escape code of practice. Safe exit is achieved by all doors open in the direction of travel without the use of a key.

| Observation | Priority | Referred To | Required By: | Task ID |
|---|---|---|---|---|
| New final exit doors fitted and communal fire door installed. | No Action | | | |
